STATE OF CONNECTICUT  
 CONNECTICUT HISTORICAL COMMISSION  
 100 Prospect Street, Hartford, Connecticut 06106  
 860-3005  
 CULTURAL RESOURCES INVENTORY FORM  
 Buildings and Structures

BUILDING NAME: Common: Old North Church Historic: Fourth Meeting House of First Church of Christ

STREET & NUMBER (and/or location): 706-712 Main Street

STYLE OF BUILDING: Federal DATE OF CONSTRUCTION: 1799

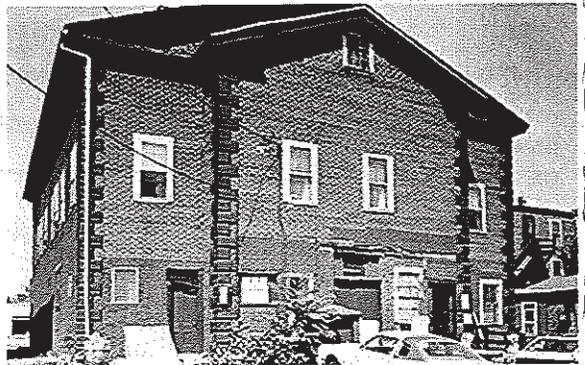
photographer: John E. Reynolds  
date: 7/78 view: east  
negative on file: Roll 29, #23A

Alterations:  no  yes, explain: Steeple removed; interior divided into apartments; asphalt siding
