ENVIRONMENTAL IMPACT ANALYSIS

PERTAINING TO WETLAND ALTERATION

BIBLE ROCK BROOK

MIDDLETOWN ,CT.

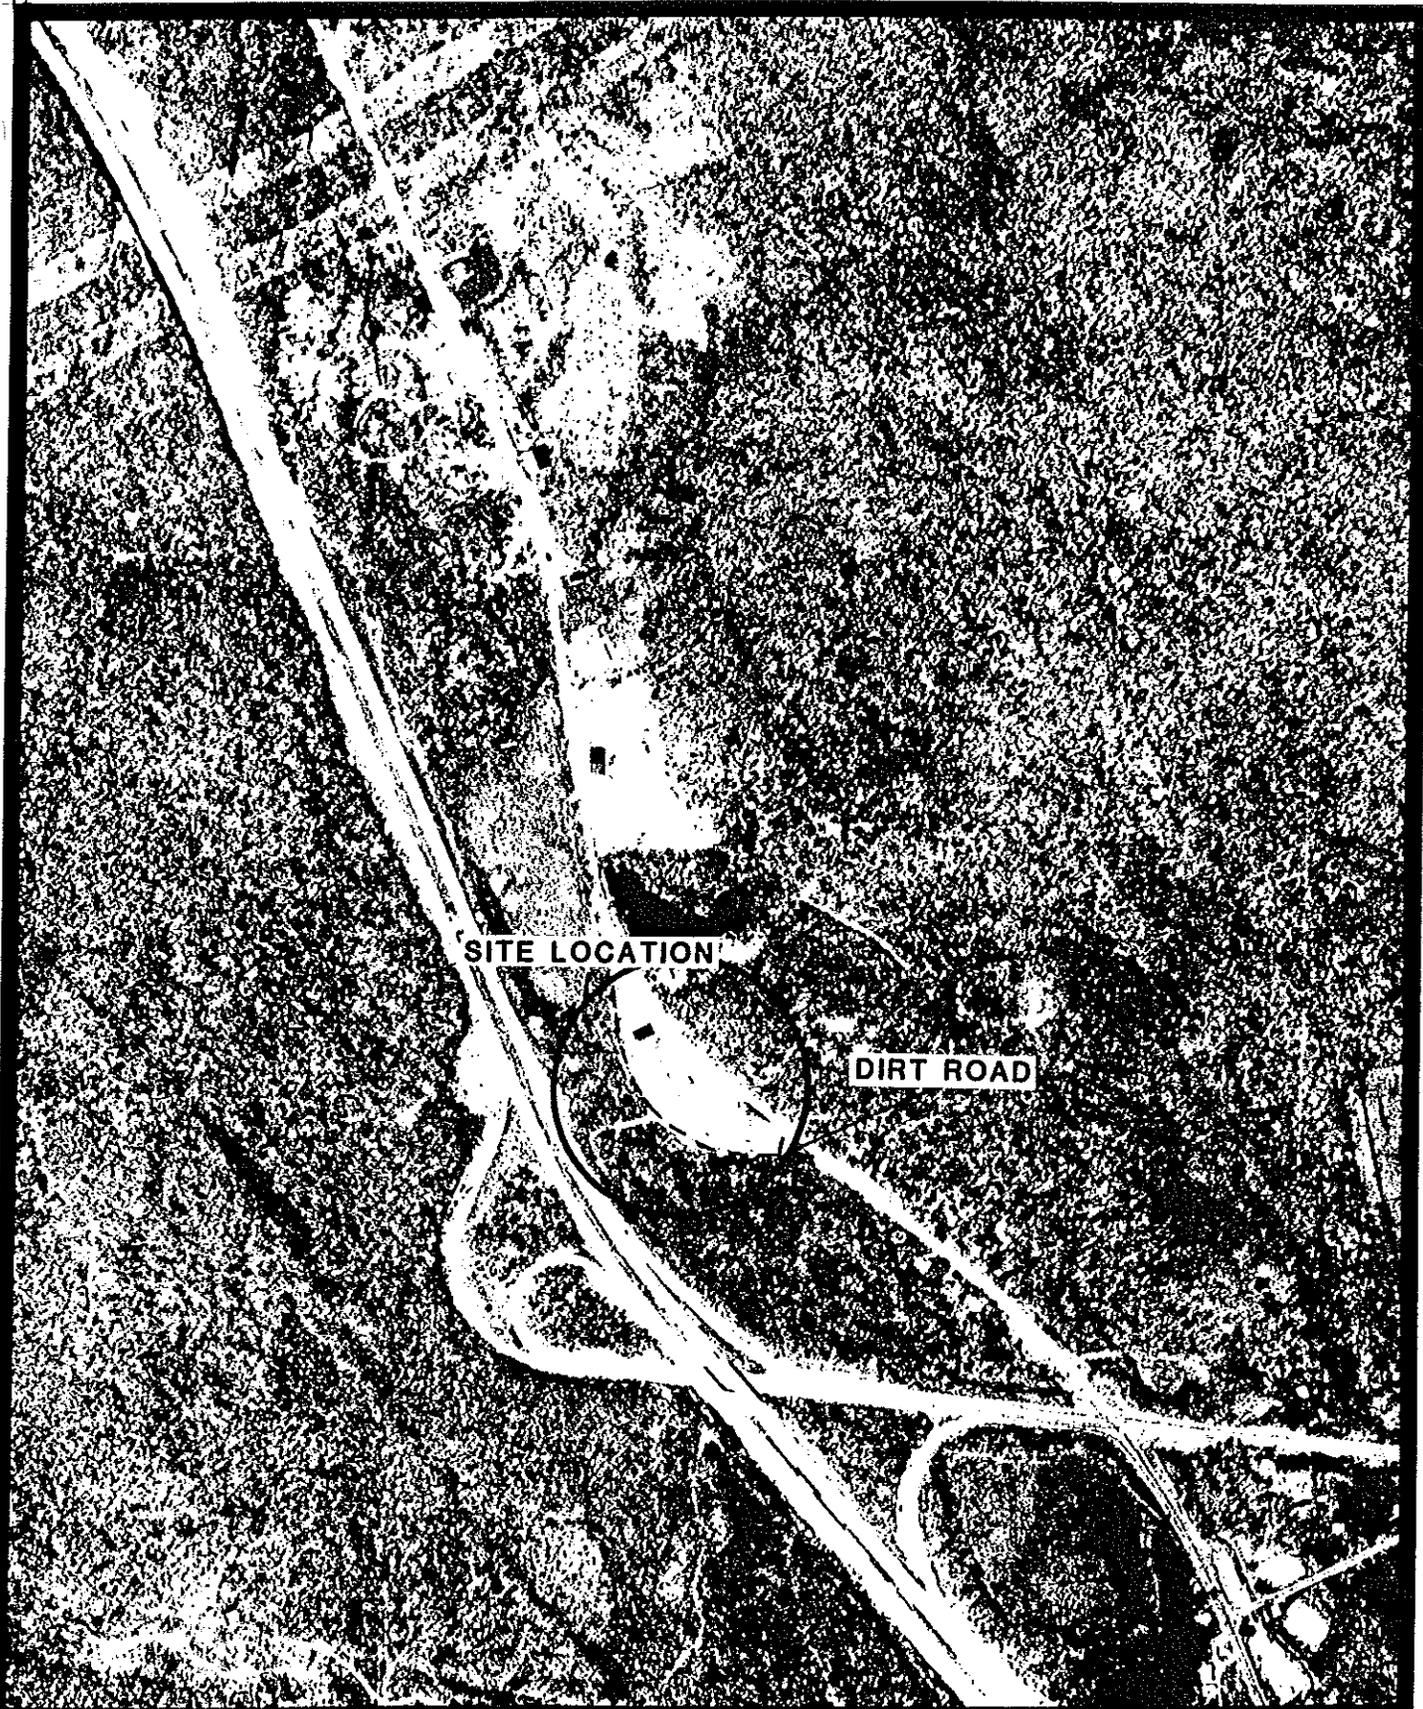
FIG. 7a

from the U.S. Soil Conservation Service in Haddam, Connecticut for the years 1979, 1980, 1982 (see Figures 7a, 7b, & 7c).

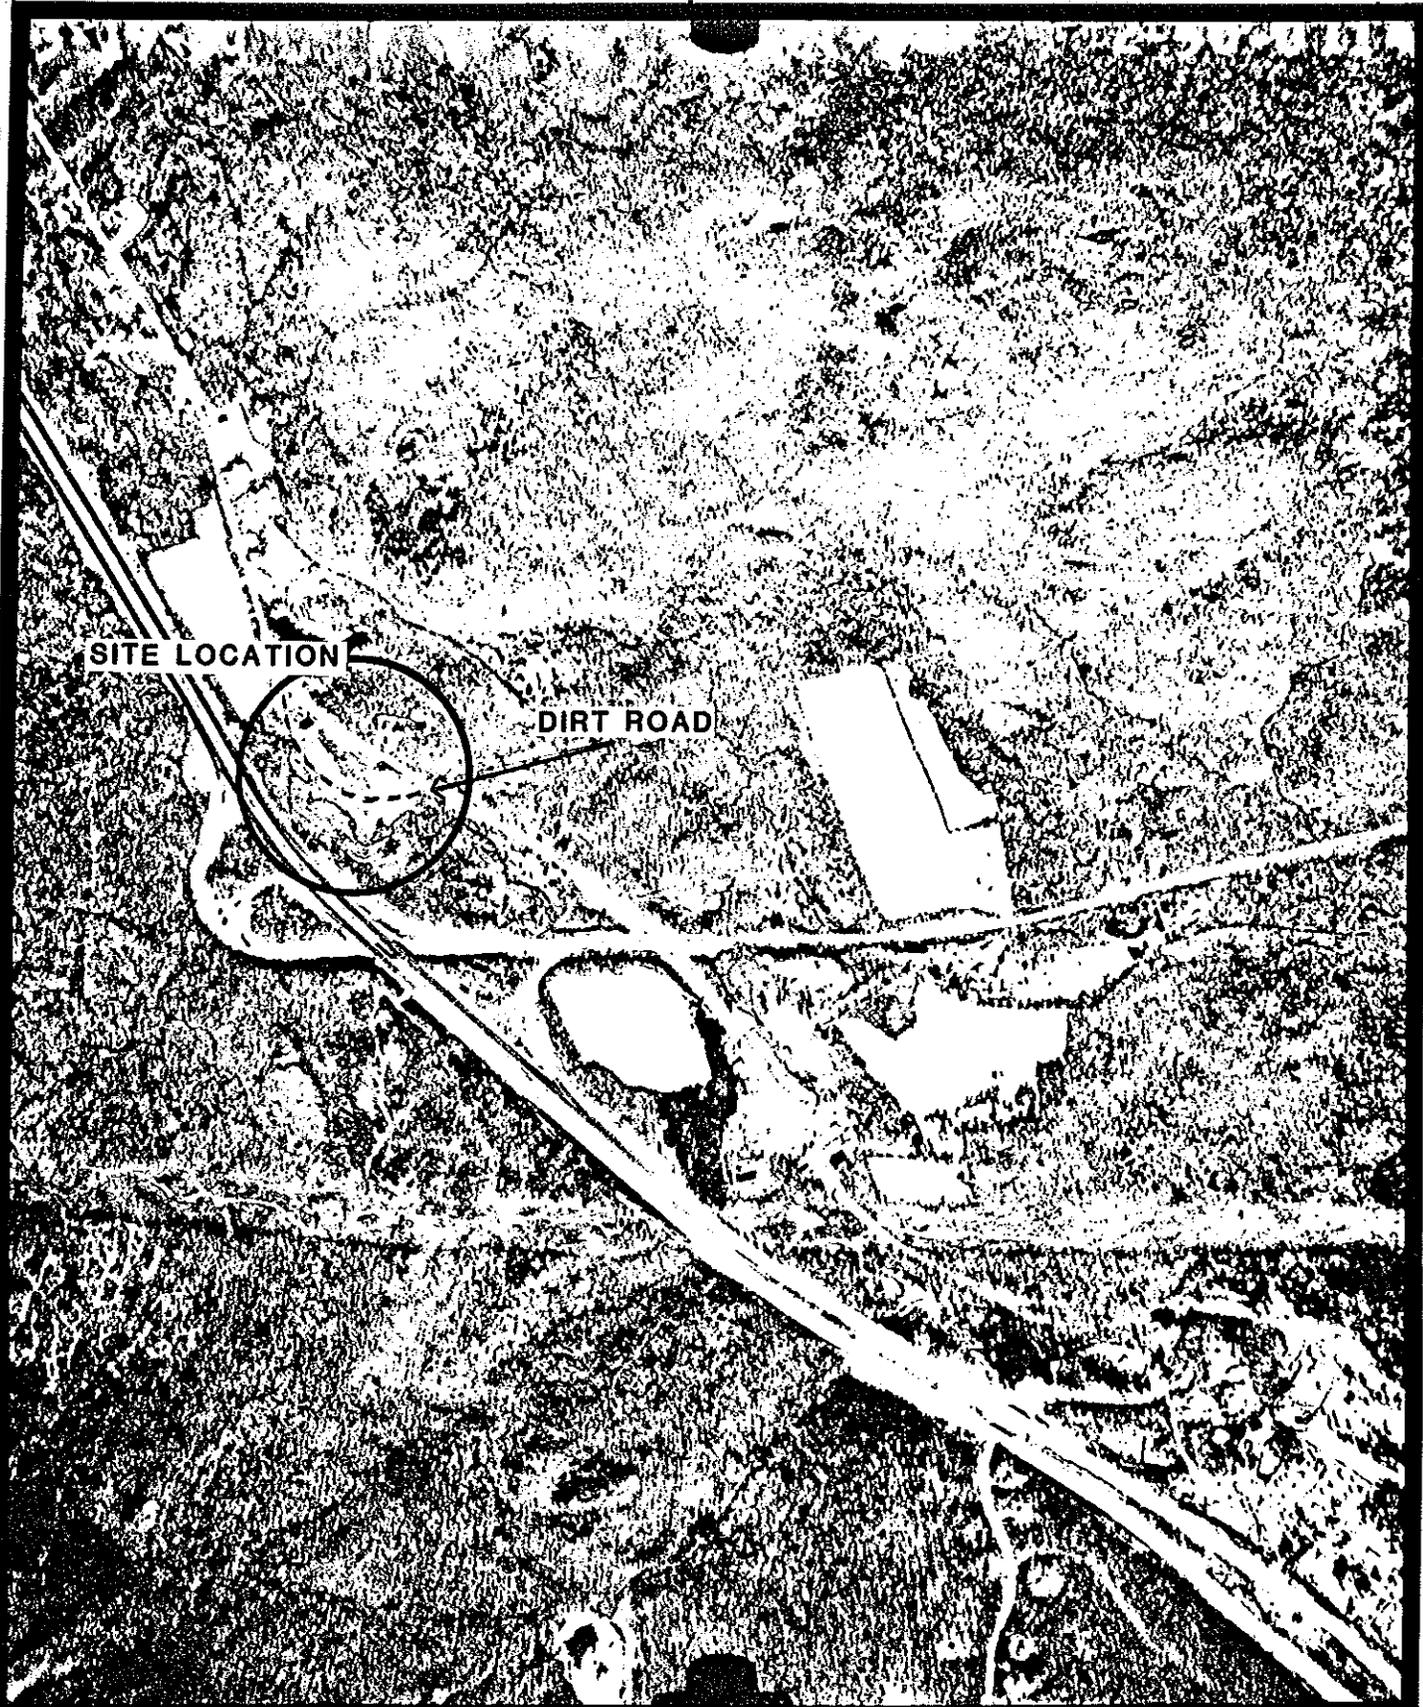
FIG. 7b

Aerial photograph 7b and Figure 4 indicate that Bible Rock Brook in the area adjacent to the site had a braided stream pattern, with at least 2-3 recognizable flow channels (see Figure 4). It appears that the northeastern channel was filled over and abandoned, while the southwestern channel was excavated to handle the flow for the entire brook entering the site.
