ASBESTOS INSPECTION

**NORTH END PROJECT PHASE 1 - FERRY STREET BUILDINGS
MIDDLETOWN, CT**

**Inspection Dates: September 1, 6, 7, 8, 9
Report Date: September 15, 2005**

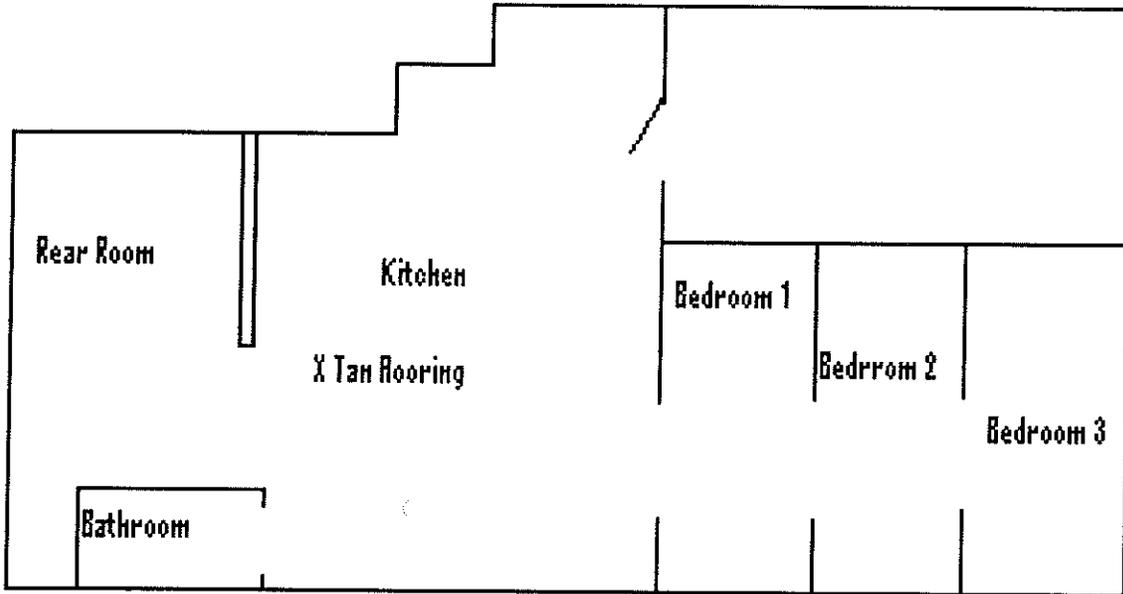
APARTMENT 2W

1. Tan Flooring in the Kitchen of Unit 2W (Approximately 160 ft²)
2. Tan Flooring in the Hallway (Approximately 60 ft²)

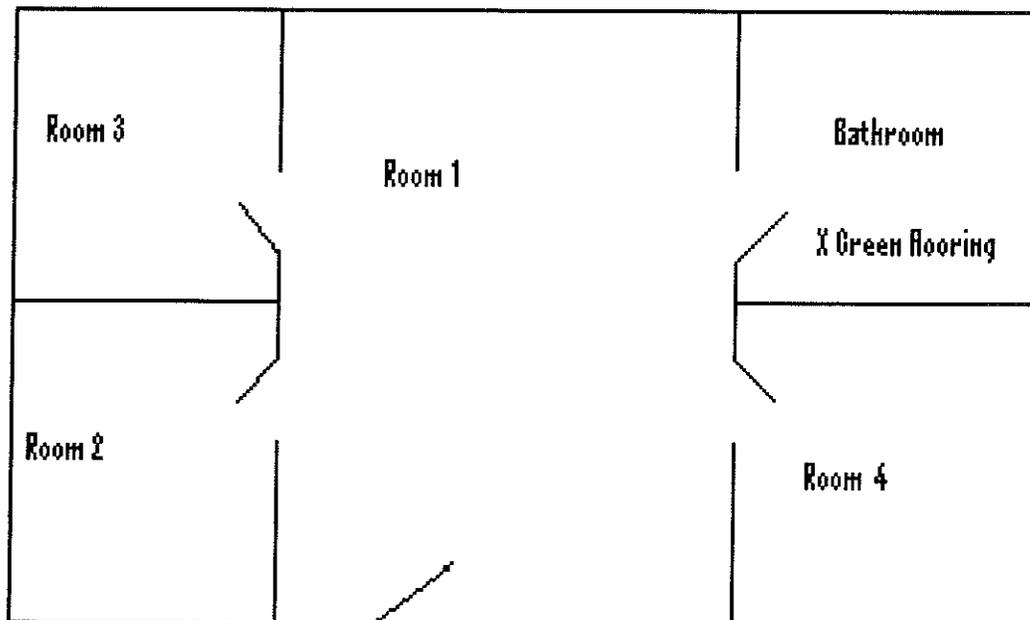
FIRST FLOOR APARTMENT 1

1. Black Roof Flashing (Approximately 250 ft²)
2. Gray Transite in Bakery Room 2 (High Ceiling Area) (Approximately 500 ft²)
3. Gray Furnace Insulation in Bakery Room 3 (Inside Red Furnace, Approximately 10 ft²)
4. Green Bathroom Flooring in Bakery Apartment 1 (Approximately 60 ft²)
5. Gray Window Glaze in Bakery Apartment 2

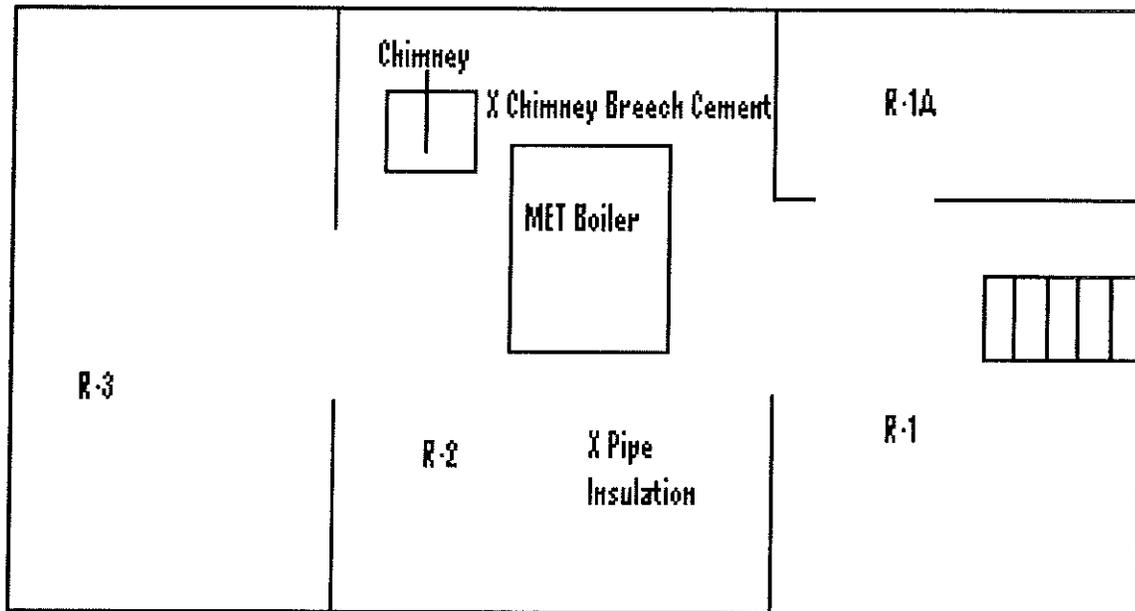
BASEMENT

1. Gray Pipe Insulation in Rooms 1, 2 & 3 of the Basement
2. Gray Pipe Fitting Insulation in Rooms 1, 2 & 3 of the Basement (Approximately 300 linear feet)
3. Gray Chimney Breech in the Basement (Approximately 1 ft²)
4. Yellow Floor Tile on the Stairs to the Attic (Approximately 40 ft²)

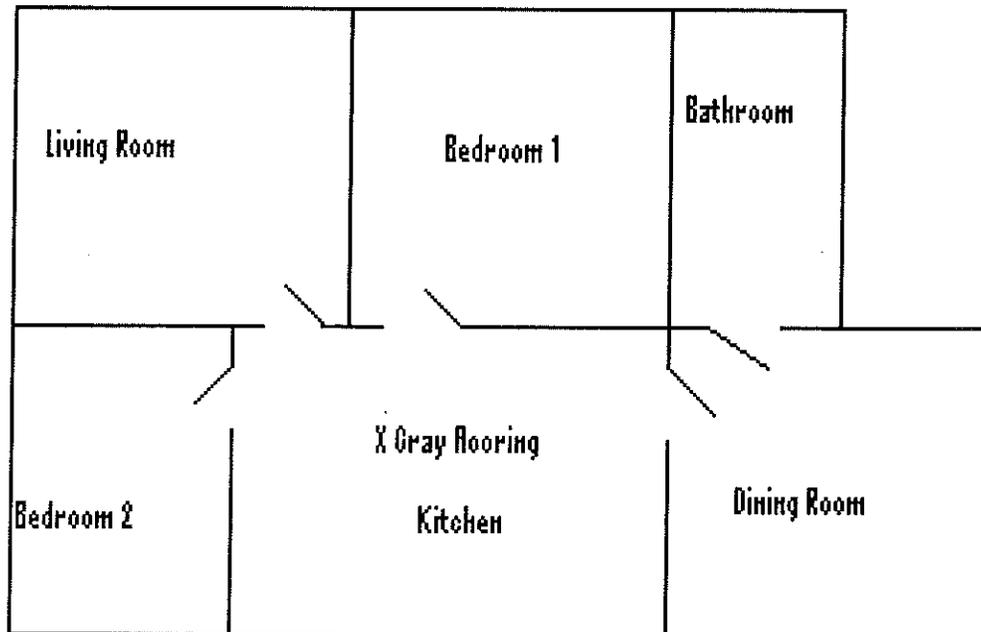
**58 FERRY STREET, 2ND FLOOR REAR
LOT #33**

1. Tan Flooring in the 1st Floor Rear Unit 3 (Approximately 120 ft²)
2. Gray Flooring in the 2nd Floor Rear Unit Kitchen (Approximately 120 ft²)
