**LEAD INSPECTION**

**NORTH END PROJECT PHASE 1 - FERRY STREET BUILDINGS  
MIDDLETOWN, CT**

**Inspection Date: September 1, 6, 9 & 12, 2005  
Report Date: September 15, 2005**

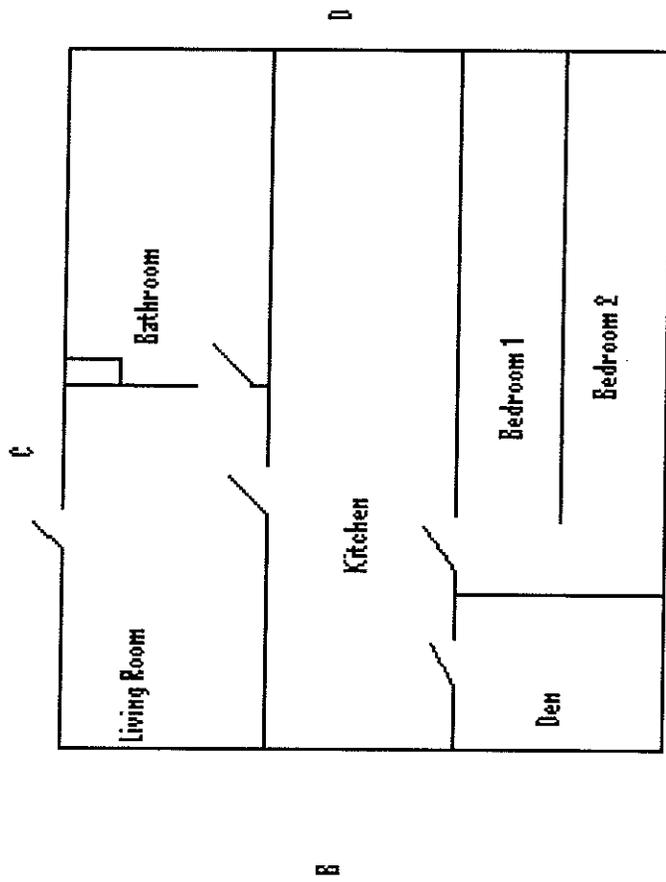
APARTMENT 2E  
36 FERRY STREET (HELD CARD LOCATION 3 FERRY  
STREET, LOT # 29)

Sample #	Location	Side	Color	Surface Type	Substrate	Paint Condition	Results Mg/cm <sup>2</sup>	Comments
3	Apartment 2E Living Room	C	White	Exterior Door Casing	Wood	Poor	>9.9	+
22	Exterior	D	Gray	Window Casing	Wood	Poor	6.9	+ Basement

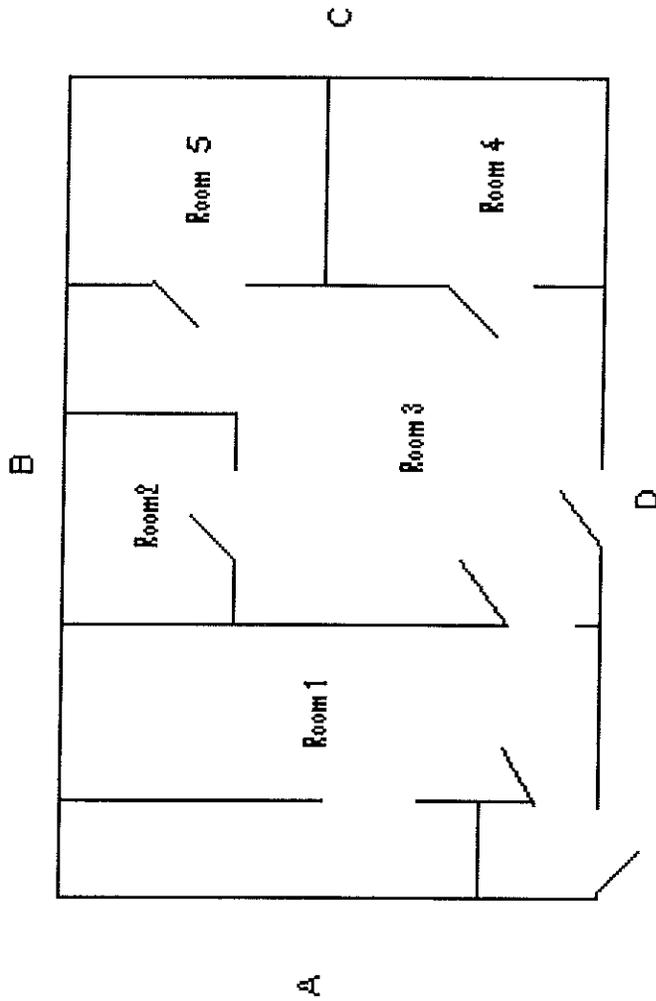
Unit 1 - Lower Level  
56 Ferry Street Front Building  
(Field Card Location 54 Ferry Street, Lot # 34)

Sample #	Location	Side	Color	Surface Type	Substrate	Paint Condition	Results Mg/cm <sup>2</sup>	Comments
29	Front Building Unit 1 Room 3	B	Gray	Wall	Plaster	Poor	4.6	+
37	Front Building Unit 1 Room 5	D	White	Window Sash	Wood	Poor	3.2	+
38	Front Building Unit 1 Room 5	D	White	Window Sash	Wood	Poor	2.8	+

Sample #	Location	Side	Color	Surface Type	Substrate	Paint Condition	Results Mg/cm <sup>2</sup>	Comments
39	Front Building Unit 1 Room 5	D	White	Window Trim	Wood	Poor	2.0	+
44	Front Building Unit 1 Room 5	A	Brown	Door Frame	Wood	Poor	1.9	+
7	Front Building Unit 2 Room 1	B	Beige	Window Well	Wood	Poor	>9.9	+
23	Front Building Unit 2 Bathroom	B	White	Window Sash	Wood	Poor	2.3	+
24	Front Building Unit 2 Bathroom	D	White	Door Casing	Wood	Fair	1.0	+
33	Front Building Unit 2 Room 4	C	Red	Window Well	Wood	Poor	2.0	+
13	Exterior	D	White	Window Casing	Wood	Poor	4.9	+ Front
14	Exterior	D	Green	Window Sash	Wood	Poor	1.6	+ Front
19	Exterior	D	Green	Siding	Wood	Intact	1.3	+ Front
20	Exterior	D	Green	Porch Wall	Wood	Intact	1.4	+ Front
21	Exterior	D	White	Wall	Wood	Poor	3.1	+ Front

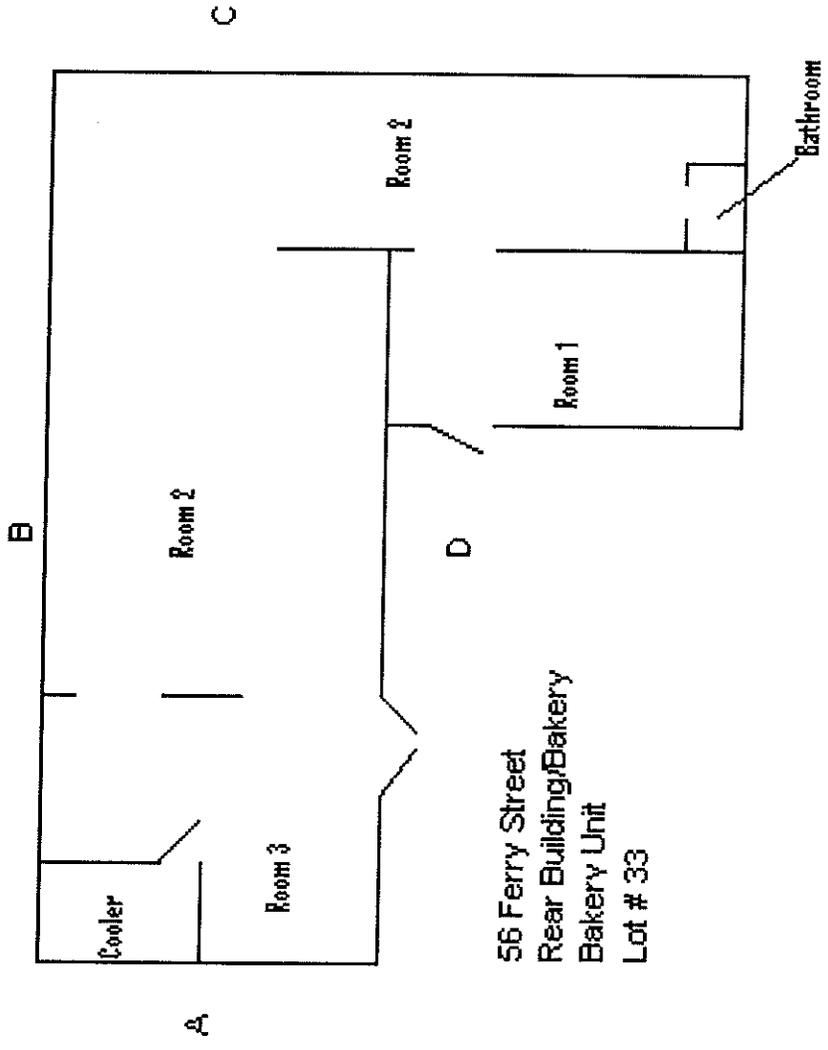
56 Ferry Street  
Rear Building/Bakery  
Bakery Unit  
Lot # 33

Sample #	Location	Side	Color	Surface Type	Substrate	Paint Condition	Results Mg/cm <sup>2</sup>	Comments
15	Rear Bldg./ Bakery Bakery Unit Bathroom	D	Blue	Door	Wood	Fair	2.3	+

Sample #	Location	Side	Color	Surface Type	Substrate	Paint Condition	Results Mg/cm <sup>2</sup>	Comments
16	Rear Bldg./ Bakery Bakery Unit Bathroom	C	Blue	Wall	Brick	Poor	1.0	+
3	Rear Bldg./ Bakery Unit 1 Room 1	D	White	Door Jamb	Wood	Poor	2.3	+
6	Rear Bldg./ Bakery Unit 1 Room 1	D	Beige	Window Sash	Wood	Poor	1.0	+
7	Rear Bldg./ Bakery Unit 1 Room 1	D	Beige	Window Well	Wood	Poor	1.0	+
12	Rear Bldg./ Bakery Unit 1 Room 2	A	White	Window Sash	Wood	Poor	2.8	+
20	Rear Bldg./ Bakery Unit 1 Room 3	B	White	Window Well	Wood	Poor	6.2	+
25	Rear Bldg./ Bakery Unit 1 Bathroom	B	White	Window Well	Wood	Poor	5.7	+
29	Rear Bldg./ Bakery Unit 1 Room 4	D	Yellow	Window Well	Wood	Poor	2.9	+
1	Rear Bldg./ Bakery Unit 2 Room 1	D	White	Window Well	Wood	Poor	2.3	+
2	Rear Bldg./ Bakery Unit 2 Room 1	D	White	Window Sash	Wood	Poor	3.8	+
3	Rear Bldg./ Bakery Unit 2 Room 1	D	Gray	Ceiling	Plaster	Poor	1.0	+
4	Rear Bldg./ Bakery Unit 2 Room 1	A	Green	Wall	Plaster	Poor	3.5	+

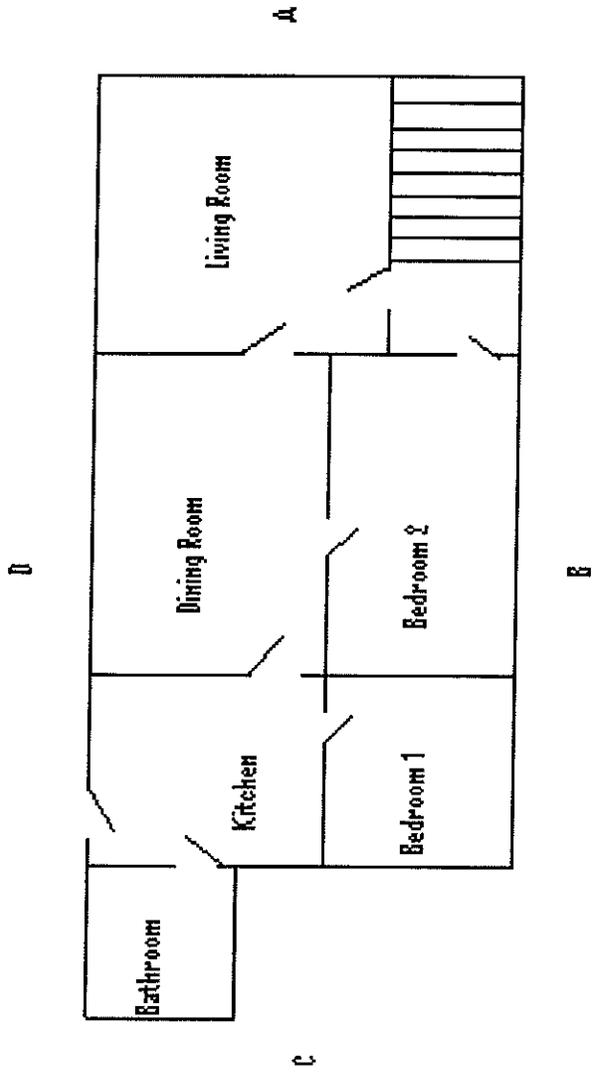
58 FERRY STREET, 2ND FLOOR FRONT  
LOT #33

Sample #	Location	Side	Color	Surface Type	Substrate	Paint Condition	Results Mg/cm <sup>2</sup>	Comments
6	2 <sup>nd</sup> Floor Front Apt. Dining Room	B	White	Door	Wood	Intact	8.3	+
7	2 <sup>nd</sup> Floor Front Apt. Dining Room	B	White	Door Casing	Wood	Intact	>9.9	+
8	2 <sup>nd</sup> Floor Front Apt. Dining Room	B	White	Baseboard	Wood	Intact	>9.9	+
10	2 <sup>nd</sup> Floor Front Apt. Kitchen	D	White	Door	Wood	Intact	>9.9	+
11	2 <sup>nd</sup> Floor Front Apt. Kitchen	D	White	Door Casing	Wood	Intact	>9.9	+

Sample #	Location	Side	Color	Surface Type	Substrate	Paint Condition	Results Mg/cm <sup>2</sup>	Comments
12	2 <sup>nd</sup> Floor Front Apt. Kitchen	D	White	Window Casing	Wood	Intact	>9.9	+
15	2 <sup>nd</sup> Floor Front Apt. Bedroom 2	A	Blue	Wall	Plaster	Intact	4.6	+
16	2 <sup>nd</sup> Floor Front Apt. Bedroom 2	A	White	Door Casing	Wood	Intact	7.1	+
18	2 <sup>nd</sup> Floor Front Apt. Bedroom 1	B	Purple	Wall	Plaster	Intact	5.6	+
30	Exterior	A	White	Door Lintel	Metal	Intact	3.1	+
4	Exterior	B	Tan	Siding	Wood	Intact	>9.9	+
5	Exterior	B	Tan	Window Casing	Wood	Intact	1.0	+
6	Exterior	B	Green	Window Casing	Wood	Poor	2.6	+
8	2 <sup>nd</sup> Floor Rear Apt. Kitchen	A	White	Wall	Plaster	Intact	2.6	+
11	2 <sup>nd</sup> Floor Rear Apt. Dining Rm.	D	White	Baseboard	Wood	Intact	>9.9	+
12	2 <sup>nd</sup> Floor Rear Apt. Bathroom	B	White	Door	Wood	Intact	>9.9	+
13	2 <sup>nd</sup> Floor Rear Apt. Bathroom	B	White	Door Casing	Wood	Intact	>9.9	+

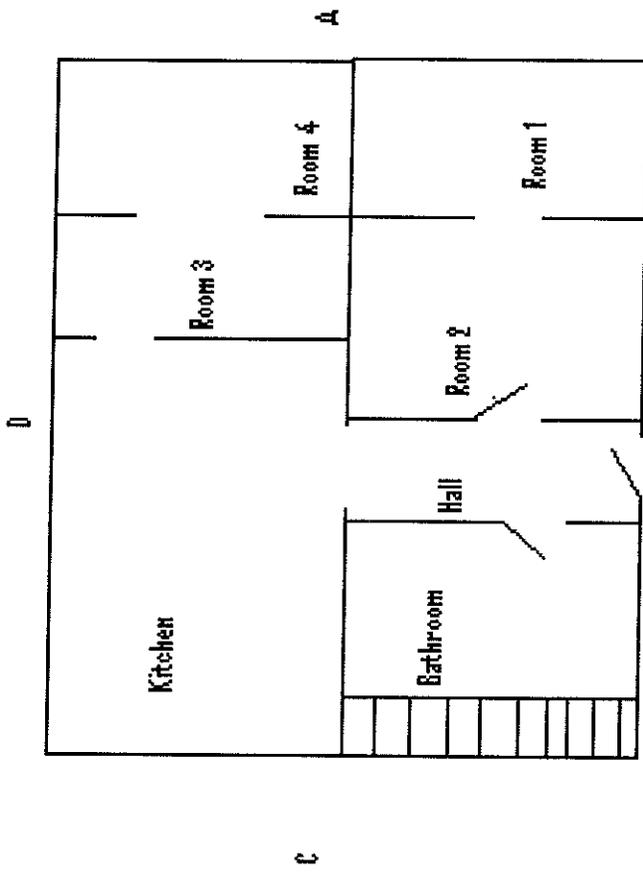
60 FERRY STREET, 2nd FLOOR FRONT  
LOT #36

Sample #	Location	Side	Color	Surface Type	Substrate	Paint Condition	Results Mg/cm <sup>2</sup>	Comments
1	2 <sup>nd</sup> Floor Front Apt Room 1	A	Blue	Wall	Plaster	Intact	1.1	+
5	2 <sup>nd</sup> Floor Front Apt Room 1	-	White	Ceiling	Plaster	Intact	1.0	+
9	2 <sup>nd</sup> Floor Front Apt Room 2	D	White	Door	Wood	Poor	>9.9	+

Sample #	Location	Side	Color	Surface Type	Substrate	Paint Condition	Results Mg/cm <sup>2</sup>	Comments
15	2 <sup>nd</sup> Floor Front Apt Room 3	C	White	Door	Wood	Intact	>9.9	+
16	2 <sup>nd</sup> Floor Front Apt Kitchen	D	White	Wall	Plaster	Intact	7.0	+
19	2 <sup>nd</sup> Floor Front Apt Bathroom	C	Tan	Wall	Plaster	Intact	1.7	+
20	2 <sup>nd</sup> Floor Front Apt Attic	C	White	Wall	Wood	Intact	6.2	+
23	Exterior	D	White	Siding	Wood	Poor	>9.9	+ under siding
25	Exterior	D	Brown	Window Frame	Wood	Poor	4.6	+
29	Exterior	C	White	Siding	Wood	Poor	>9.9	+
30	Exterior	D	Brown	Window Frame	Wood	Poor	3.2	+
32	Exterior	D	White	Door Casing	Wood	Poor	2.1	+
35	Exterior	D	White	Window Casing	Wood	Poor	6.1	+
38	Exterior	A	White	Window Sill	Wood	Poor	>9.9	+
