HISTORIC RESOURCES INVENTORY FORM
For Buildings and Structures

- 1. BUILDING NAME: Common: Wilcox, Crittenden & Co. Historic: Pameacha Manufacturing Co.
- 2. TOWN/CITY: Middletown VILLAGE: _____ COUNTY: Middlesex
- 3. STREET & NUMBER (and/or location): 234 South Main Street
- 4. OWNER(S): Gulf and Western Precision Engineering Company PUBLIC PRIVATE
- 5. USE: Present: Vacant Historic: Woolen factory; marine hardware factory
- 6. ACCESSIBILITY TO PUBLIC: Exterior visible from public road: yes ___ no
Interior accessible: ___ yes, explain _____ no

Pamecha Manufacturing Co.

234 South Main St., Middletown, Ct. 06457

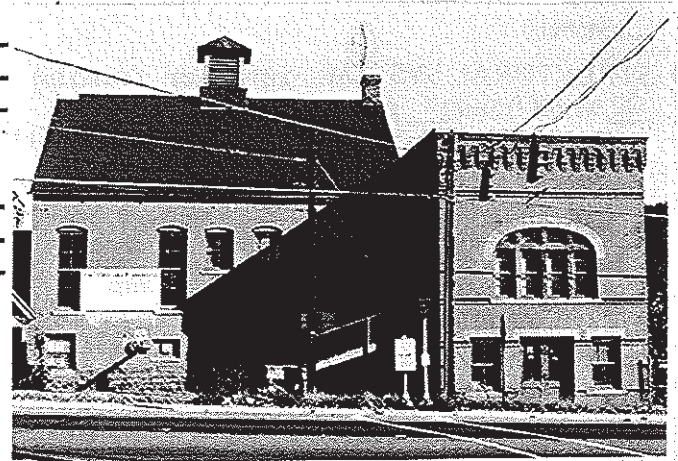
photographer: Elizabeth Loomis
date: 10/78 view: west
negative on file: Roll 46, #11

- 12. CONDITION: Structural: ___ excellent good ___ fair ___ deteriorated
 Exterior: ___ excellent good ___ fair ___ deteriorated

13. INTEGRITY: Location: on original site ___ moved, when: _____
 Alterations: ___ no yes, explain: Cupola replaced; early interior adjustments; win-
dows altered; south addition

This two and one half story brick structure displays some of its early exterior features; brownstone sills and lintels, and two corbelled chimneys. The windows on the west facade were lengthened, the brownstone lintels removed and replaced by segmental-arched brick lintels. The cupola (which appears on an 1825 map) was replaced. The wing, attached to its south wall, probably dates from the late 19th century. More decorative, it displays corbelled brick work and an unusual arched window on the west facade. A large mural of a clipper ship is painted on the south wall.
