HISTORIC RESOURCES INVENTORY FORM
For Buildings and Structures

- 1. BUILDING NAME: Common: Old Middlesex Theater Historic: Middlesex Opera House
- 2. TOWN/CITY: Middletown VILLAGE: _____ COUNTY: Middlesex
- 3. STREET & NUMBER (and/or location): 109-111 College Street
- 4. OWNER(S): City of Middletown PUBLIC PRIVATE
- 5. USE: Present: Vacant Historic: Opera House; Movie Theater
- 6. ACCESSIBILITY TO PUBLIC: Exterior visible from public road: yes no
Interior accessible: yes, explain with permission of Redevelopment Agency no

Middlesex Opera House
109-111 College Street, Middletown, Ct. 06457

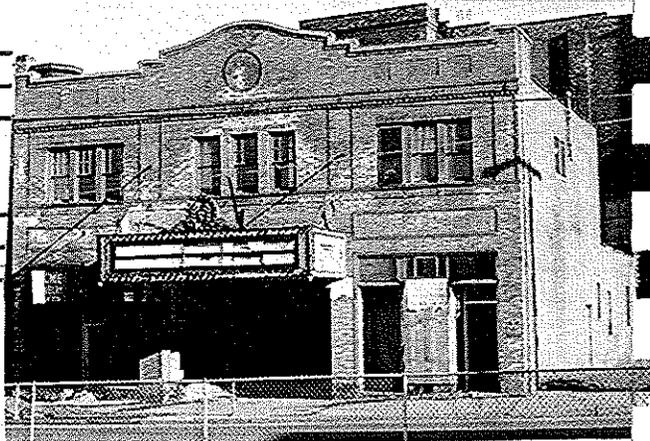
PHOTOGRAPH

16. INTERRELATIONSHIP OF BUILDING AND SURROUNDINGS: The two story theater entrance facing north on College Street presents the largest facade in an area of small 19th century commercial buildings; it also contrasts stylistically. Together with the large theater behind it, it is included in a proposed historic district covering the west side of Main Street from College Street to Church Street.

photographer: Robert Svec
 date: 3/78 view: north
 negative on file: Roll 20, #35
