HISTORIC RESOURCES INVENTORY FORM

1. BUILDING NAME: Common: \_\_\_\_\_ Historic: South Congregational Church parsonage
2. TOWN/CITY: Middletown VILLAGE: \_\_\_\_\_ COUNTY: Middlesex
3. STREET & NUMBER (and/or location): 60 Crescent Street
4. OWNER(S): Middlesex Memorial Hospital PUBLIC  PRIVATE
5. USE: Present: Vacant Historic: South Congregational parsonage
6. ACCESSIBILITY TO PUBLIC: Exterior visible from public road:  yes  no  
Interior accessible:  yes, explain \_\_\_\_\_  no

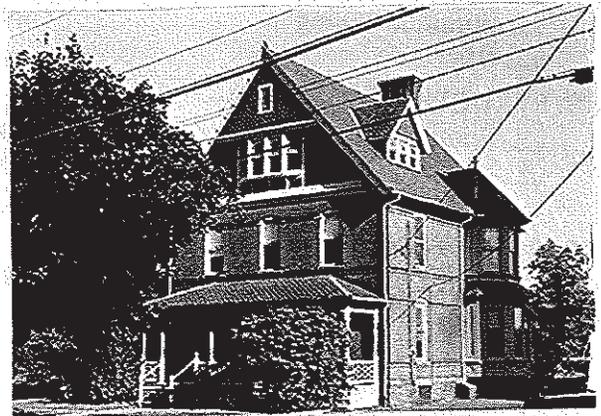
PHOTOGRAPH

This building displays the picturesque form of the Queen Anne style; multi-gabled roof, polygonal turrets, and projecting attic gables. A variety of textures and materials are employed; fish-scale patterned slate, decorative brick, and wooden stickwork. The building is further embellished by rounded arched windows, sashes with small square lights, large chimneys with terra cotta panels, and a four-bay oriel in the slate-paneled facade gable.

photographer: Elizabeth Loomis  
date: 10/78 view: northwest  
negative on file: Roll 46, #20
