HISTORIC RESOURCES INVENTORY FORM
For Buildings and Structures

- 1. BUILDING NAME: Common: Wesleyan Argus Building Historic: Commons Club
- 2. TOWN/CITY: Middletown VILLAGE: _____ COUNTY: Middlesex
- 3. STREET & NUMBER (and/or location): 167 High Street
- 4. OWNER(S): Wesleyan University PUBLIC PRIVATE
- 5. USE: Present: Residence Historic: same
- 6. ACCESSIBILITY TO PUBLIC: Exterior visible from public road: yes no
Interior accessible: yes, explain with tenant's permission no

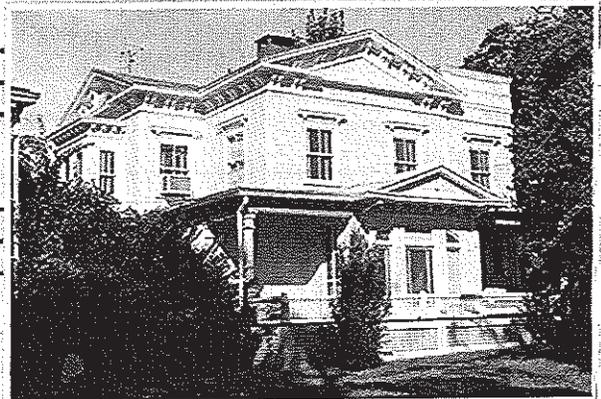
photographer: Roger Sherman
date: 9/78 view: southeast
negative on file: Roll 38, #17

Stained glass windows, center front
Paired brackets along whole cornice, including pedimented gables
Matching window caps with paired brackets, second story

The building is long and narrow, with an added wing and porches. A nineteenth century photograph shows that the northeast tower once was one story taller. On the east facade, an extension of the first floor front room is carried forward on to the porch, making an alcove office there. One of the chief features of note is the extensive wooden brackets that surround the building supporting the cornice. These detailed brackets are displayed in pairs around the whole building. The wooden bracketed lintels, bay windows, and veranda with projecting pediment also add distinctiveness to this clapboarded building.
