HISTORIC RESOURCES INVENTORY FORM
For Buildings and Structures

- 1. BUILDING NAME: Common: _____ Historic: Lawton & Wall Block
- 2. TOWN/CITY: Middletown VILLAGE: _____ COUNTY: Middlesex.
- 3. STREET & NUMBER (and/or location): 562-576 Main Street (east side)
- 4. OWNER(S): See next page (below #21) PUBLIC PRIVATE
- 5. USE: Present: Commercial Historic: same
- 6. ACCESSIBILITY TO PUBLIC: Exterior visible from public road: yes no
Interior accessible: yes, explain commercial use no

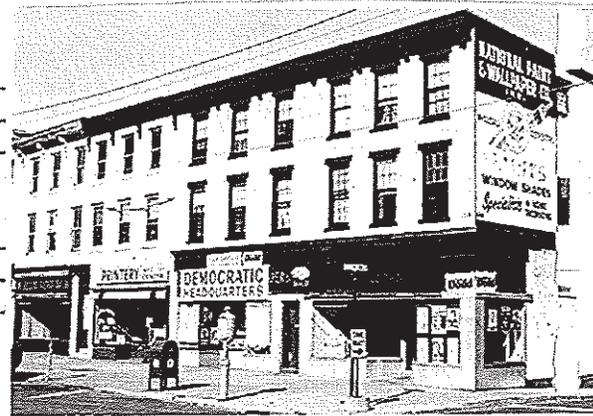
photographer: Elizabeth Loomis
date: 10/78 view: east
negative on file: Roll 46, #3-3A

- 11. NUMBER OF STORIES: 3 APPROXIMATE DIMENSIONS: 20'x55' (each section)
- 12. CONDITION: Structural: excellent good fair deteriorated
Exterior: excellent good fair deteriorated

- 13. INTEGRITY: Location: on original site moved, when: _____
Alterations: no yes, explain: Storefront alterations; brick painted
- 14. RELATED OUTBUILDINGS OR LANDSCAPE FEATURES:
 barn shed garage other landscape features or buildings: passway in rear
 carriage house shop garden

Bracketed cornice, #560-576

Metal cornice over first floor storefront, #574-576
