HISTORIC RESOURCES INVENTORY FORM

1. BUILDING NAME: Common: Jim's Flower Shop; Victor Shoe Repair Historic: Peter Butler Homestead
2. TOWN/CITY: Middletown VILLAGE: _____ COUNTY: Middlesex
3. STREET & NUMBER (and/or location): 590-594 Main Street
4. OWNER(S): Douglas R. Sr., Douglas R. Jr., & William B. Magee PUBLIC PRIVATE
5. USE: Present: Commercial Historic: Residential
6. ACCESSIBILITY TO PUBLIC: Exterior visible from public road: yes no
Interior accessible: yes, explain with owner's permission no

Peter Butler Homestead
590-594 Main Street, Middletown, Ct. 06457

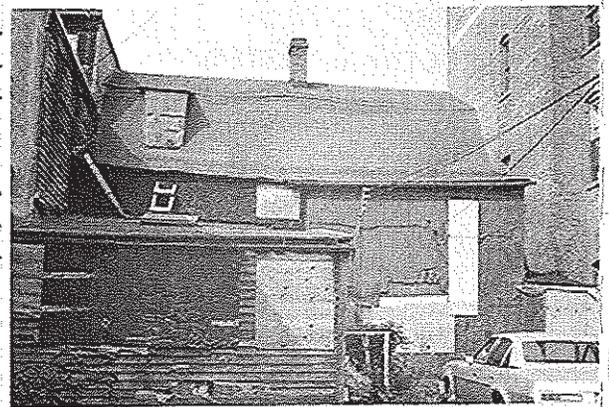
A

15. SURROUNDING ENVIRONMENT:
 open land woodland residential scattered buildings visible from site
 commercial industrial rural high building density
16. INTERRELATIONSHIP OF BUILDING AND SURROUNDINGS: Sited in a row of taller, substantial commercial buildings along the east side of Main Street in the North End, the Peter Butler Homestead is hidden behind deteriorating shop fronts and second-story wooden signboards that obscure its eighteenth century origin.

photographer: Elizabeth Loomis
date: A: 5/78; B: 8/78 view: A: east; B: west
negative on file: A: Roll 25A, #28; B: Roll 33, #27

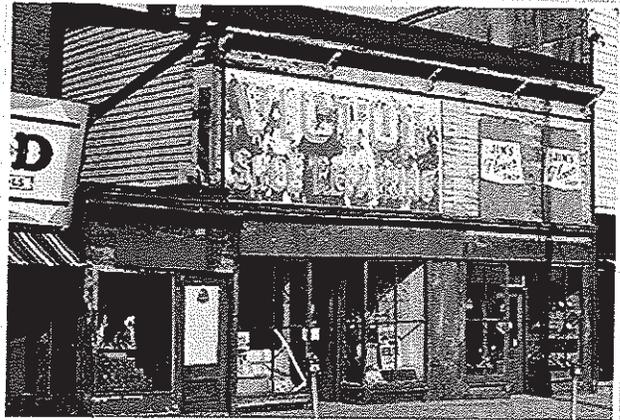
B

Viewed from the rear, the building's basic form and age are apparent. It is a two and one-half story gambrel-roofed cottage with the chimney slightly off center. Narrow clapboards are visible on the north gable end. There have been severe alterations: the center chimney has been reduced to one stack; the first floor has been converted into

shop usage; clapboarding on the rear is covered with roll asphalt; and two added rear sheds are in disrepair.
