HISTORIC RESOURCES INVENTORY FORM
For Buildings and Structures

- 1. BUILDING NAME: Common: Formatron Corporation Historic: L.D. Brown & Son
- 2. TOWN/CITY: Middletown VILLAGE: _____ COUNTY: Middlesex
- 3. STREET & NUMBER (and/or location): 128 Main Street Extension
- 4. OWNER(S): Miller Associates PUBLIC PRIVATE
- 5. USE: Present: Industrial Historic: same
- 6. ACCESSIBILITY TO PUBLIC: Exterior visible from public road: yes no
Interior accessible: yes, explain _____ no

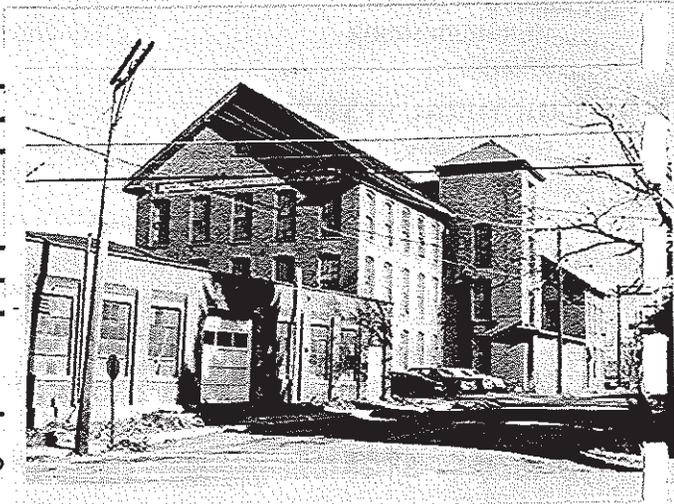
photographer: Robert Svec
date: 12/78 view: southwest
negative on file: Roll 53, #18A

The large main factory is 3½ stories in height. Its broad, plain walls are topped by a wide wooden cornice beneath the long gabled roof. This and a rear wing comprised the original building. Between 1877 and 1896, an office and an extension to the wing were erected. These ell's display decorative brick beltcourses. An addition that connects the office to rear wing, constructed in this century, further enlarged the structure. A tall smoke stack and a distinctive tower that crowned the stairwell were removed sometime after 1896.
