HISTORIC RESOURCES INVENTORY FORM
For Buildings and Structures

- 1. BUILDING NAME: Common: _____ Historic: Timothy Gilbert House
- 2. TOWN/CITY: Middletown VILLAGE: _____ COUNTY: Middlesex
- 3. STREET & NUMBER (and/or location): 1252 Newfield Street
- 4. OWNER(S): John S. Grassi et al. PUBLIC PRIVATE
- 5. USE: Present: Residence Historic: same
- 6. ACCESSIBILITY TO PUBLIC: Exterior visible from public road: yes no
Interior accessible: yes, explain _____ with permission _____ no

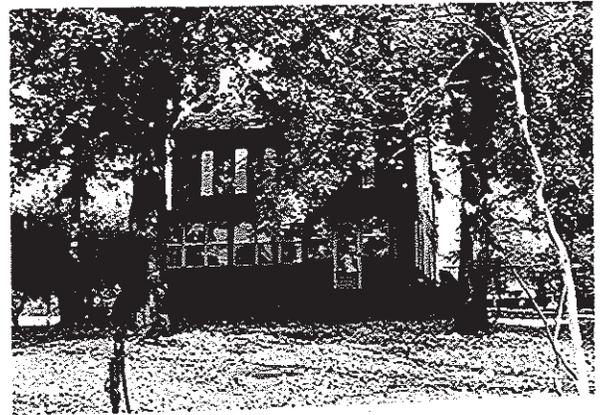
PHOTOGRAPH

16. INTERRELATIONSHIP OF BUILDING AND SURROUNDINGS: This brick, Federal-period house faces west from the east side of Newfield Street near the Cromwell line. It is set back from the street on a slight rise, and is shaded by several large trees in front. This area of Newfield is a mixture of scattered residences and small industries in an open, rural setting.

A large rear wing and an enclosed front porch across the width of the house have altered the original appearance of the house; however, as the only brick house of its type outside the urban center of Middletown, it is a unique survival.

photographer: Roseanne Fitzgerald
date: 10/78 view: west
negative on file: Roll 48. #27A
