HISTORIC RESOURCES INVENTORY FORM

- 1. BUILDING NAME: Common: _____ Historic: _____
- 2. TOWN/CITY: Middletown VILLAGE: _____ COUNTY: Middlesex
- 3. STREET & NUMBER (and/or location): 572 Saybrook Road
- 4. OWNER(S): Leo and Gertrude Klare PUBLIC PRIVATE
- 5. USE: Present: Residence Historic: same
- 6. ACCESSIBILITY TO PUBLIC: Exterior visible from public road: yes no
Interior accessible: yes, explain _____ no

- 7. STYLE OF BUILDING: Center-Chimney Colonial DATE OF CONSTRUCTION: late 18th C. Probably

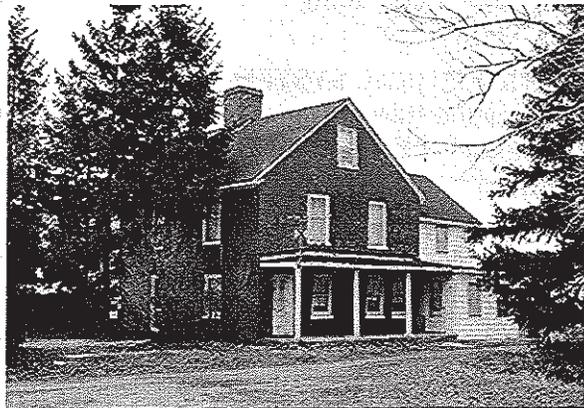
photographer: Robert Svec
date: 11/78 view: southwest
negative on file: Roll 52, #32A

16. INTERRELATIONSHIP OF BUILDING AND SURROUNDINGS: This brick structure is sited close to Saybrook Road, Route 9A. Its west wall is set into a small knoll and a low retaining wall extends south towards the highway. Development has changed this area once characterized by farmland. East, a road leads to a tract of recently built houses. A car dealership, small grocery store, and drive-in theater are nearby.

18. HISTORICAL OR ARCHITECTURAL IMPORTANCE: This brick building's appearance suggests that it was constructed during the late eighteenth century. However, it may have been built in the early 1800s, patterned after the familiar Colonial style. The broad gabled roof is topped by a large center-chimney. Its three-bay facade, running parallel to the roof ridge, has a central entranceway.

The structure is one of the best-preserved early homes on Saybrook Road. Its notability is also enhanced by its unusual placement. Sited against a small knoll, the north wall of the first story is set into the slope. A low retaining wall, constructed of brownstone, extends from the facade towards the highway.
