HISTORIC RESOURCES INVENTORY FORM
For Buildings and Structures

- 1. BUILDING NAME: Common: St. John's Rectory Historic: same
- 2. TOWN/CITY: Middletown VILLAGE: _____ COUNTY: Middlesex
- 3. STREET & NUMBER (and/or location): 19 St. John's Square
- 4. OWNER(S): St. John's Church PUBLIC PRIVATE
- 5. USE: Present: Rectory Historic: same
- 6. ACCESSIBILITY TO PUBLIC: Exterior visible from public road: yes no
Interior accessible: yes, explain _____ by appointment no

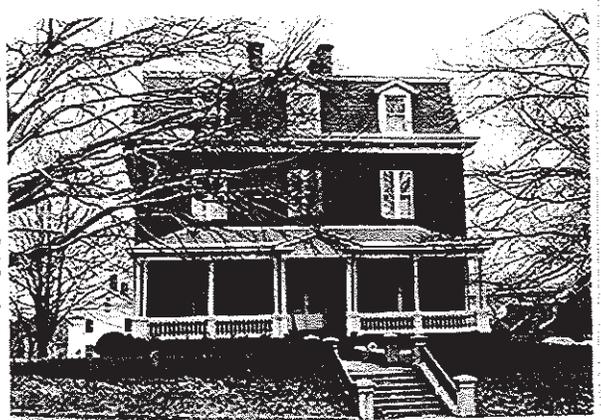
photographer: Elizabeth Loomis
date: 2/79 view: south
negative on file: Roll 59, #19

The structure displays many elements of Second Empire style that are echoed in the homes of prominent men of the period. A slated mansard roof with gabled dormer windows surmounts a bold cornice. All windows are topped by carved brownstone lintels. An Italianate-style porch, added later, stretches across the first floor facade.
