HISTORIC RESOURCES INVENTORY FORM
For Buildings and Structures

- 1. BUILDING NAME: Common: _____ Historic: Benjamin Butler House
- 2. TOWN/CITY: Middletown VILLAGE: _____ COUNTY: Middlesex
- 3. STREET & NUMBER (and/or location): 160 Washington Street
- 4. OWNER(S): Kalman Palmer PUBLIC PRIVATE
- 5. USE: Present: Residence Historic: same
- 6. ACCESSIBILITY TO PUBLIC: Exterior visible from public road: yes no
Interior accessible: yes, explain _____ no

- 7. STYLE OF BUILDING: Second Empire DATE OF CONSTRUCTION: 1867-1870
- 8. MATERIAL(S) (indicate use or location when appropriate):
 clapboard ___ asbestos siding ___ brick
 ___ wood shingle ___ asphalt siding ___ fieldstone
 ___ board & batten ___ stucco ___ cobblestone
 ___ aluminum siding ___ concrete: type: _____ cut stone: type: brownstone foundation
 ___ other: _____

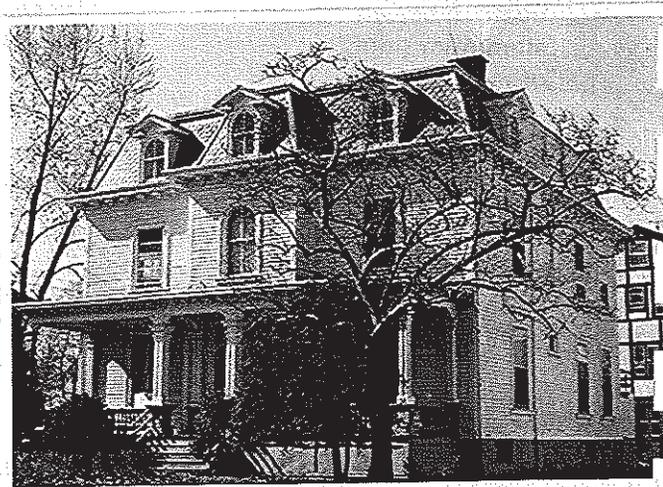
photographer: Robert Svec
date: 3/78 view: southeast
negative on file: Roll 20, #10

- 13. INTEGRITY: Location: on original site Full length veranda added to front entrance porch;
 Alterations: ___ no yes, explain: some interior alteration; slight fire damage 4/78

The house retains most of its original exterior detail (with the exception of storm windows and a later but sympathetic veranda), and is a good example of a relatively modest and unfauciful version of the Second Empire style. It displays typical Second Empire features such as cubicle form, slate mansard roof, and pedimented dormer windows, but not the often seen boldly modeled decorative forms.

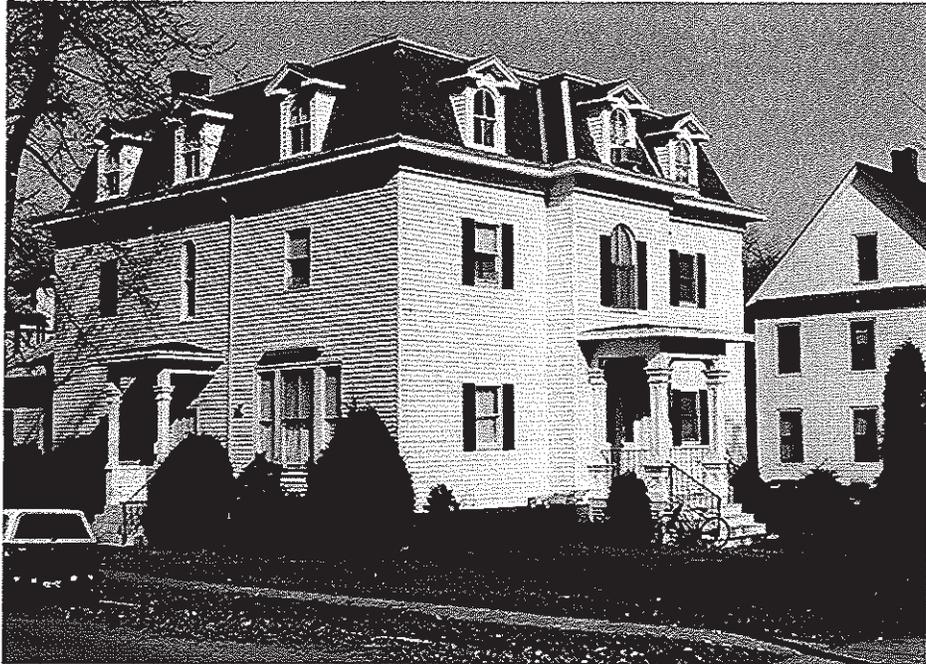
Benjamin Butler House

160 Washington Street, Middletown, CT 06457
