HISTORIC RESOURCES INVENTORY FORM
for Buildings and Structures

- 1. BUILDING NAME: Common: C.B. Stone Historic: Alms House
- 2. TOWN/CITY: Middletown VILLAGE: _____ COUNTY: Middlesex
- 3. STREET & NUMBER (and/or location): 53 Warwick Street
- 4. OWNER(S): C.B. Stone Company PUBLIC PRIVATE
- 5. USE: Present: Offices Historic: Poorhouse; factory
- 6. ACCESSIBILITY TO PUBLIC: Exterior visible from public road: yes no
Interior accessible: yes, explain with permission no

Alms House
53 Warwick Street, Middletown, Ct. 06457

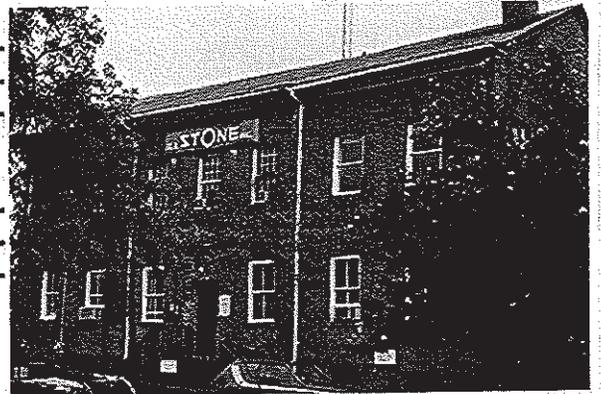
photographer: Elizabeth Loomis
date: 7/78 view: north (slightly west)
negative on file: Roll 34, #6

- 15. SURROUNDING ENVIRONMENT:
 open land woodland residential scattered buildings visible from site
 commercial industrial rural high building density
- 16. INTERRELATIONSHIP OF BUILDING AND SURROUNDINGS: This 3½ story brick structure faces north from the south side of residential Warwick Street. It sets back from the road behind two late nineteenth century houses. A large oak tree to the west shades this structure.

The Alms House is one of the largest structures of the Federal period in Middletown. Its central, slightly projecting, pavillion is still discernible. A graphic depiction on an 1825 map indicates that the building was embellished by a segmental arch over the entrance door and a classical cupola.
