City of Middletown

Downtown Housing Charrette Findings & Downtown Visual Preference Survey Results

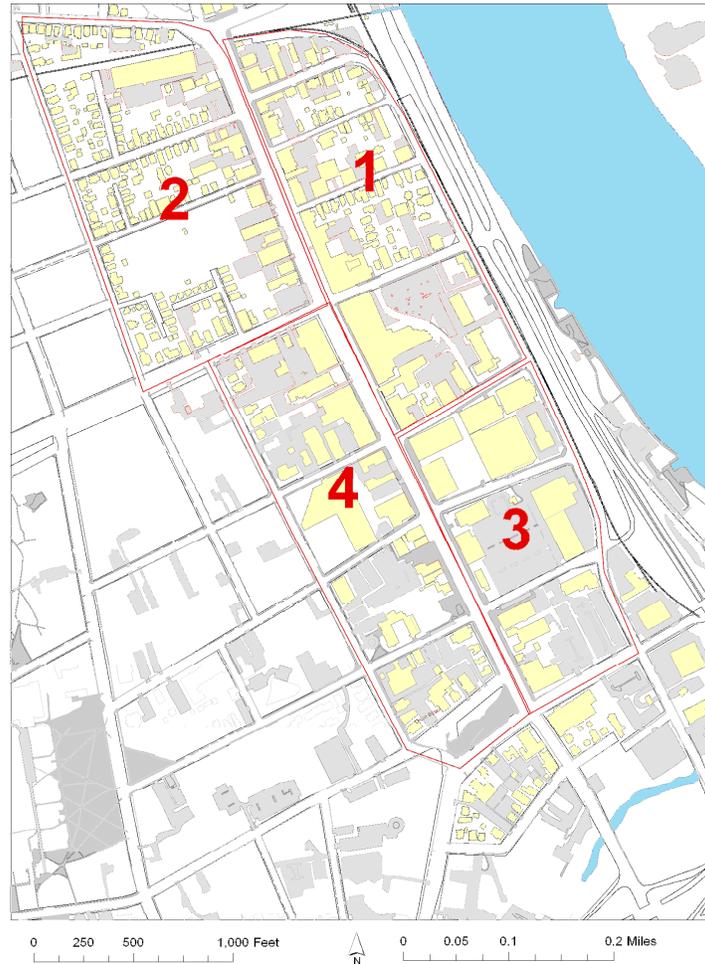
Map 1- Study Area Map

The participants of the charrette were divided into four teams and were each given a section of the downtown and asked to draw on a map what they would change, add, or remove to that area to improve it. The four areas were:

- 1) The blocks bound by Rapallo Aveune, Main Street Court Street, and DeKoven Drive;
- 2) The blocks bound by Spring Street, Pearl Street, Washington Street and Main Street;
- 3) The blocks bound by Court Street, Main Street and Union Street and DeKoven Drive; and,
- 4) The Blocks bound by Washington Street, Broad Street, Old Church Street and Main Street.

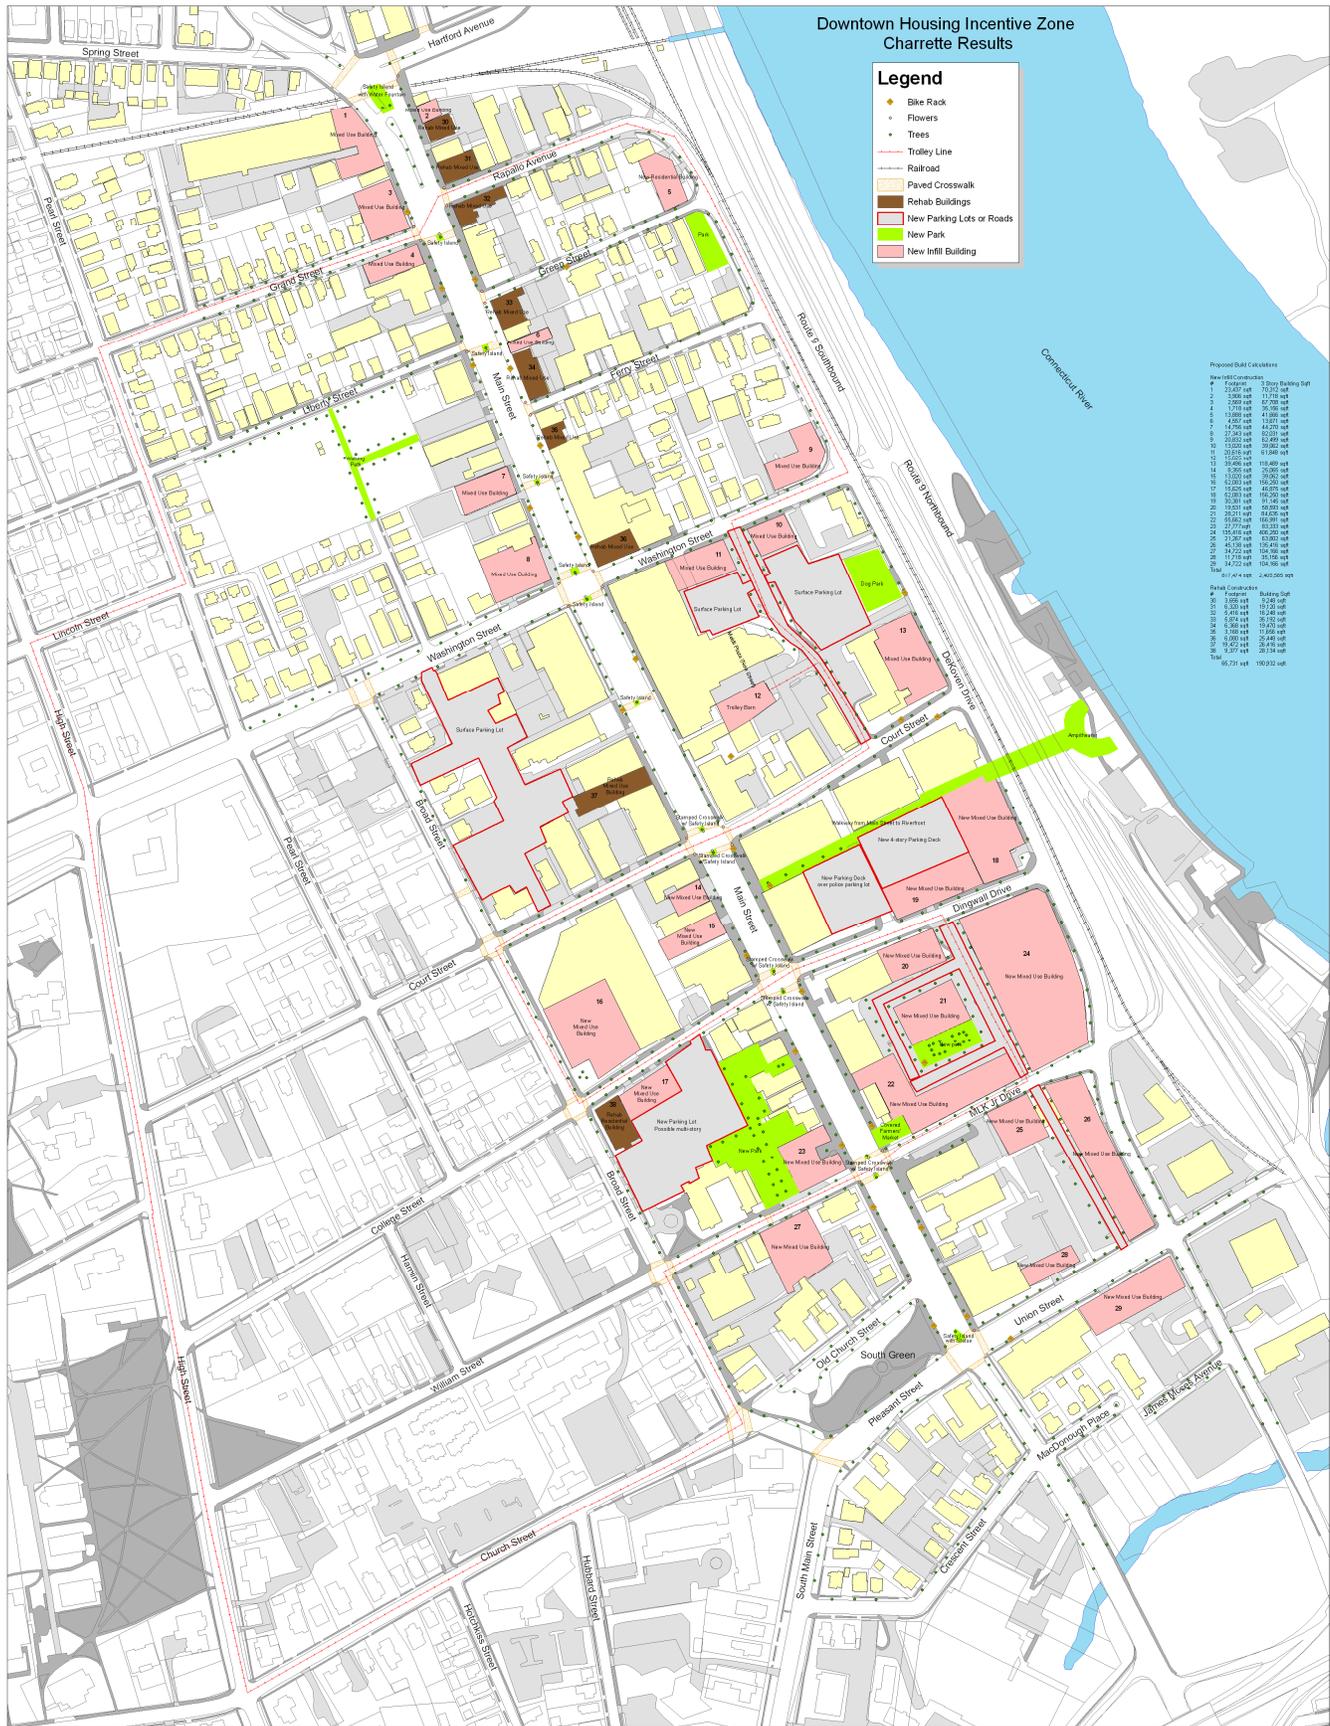
Map 2- Combined Concept Map

The participants, while in separate groups developed ideas along the same general themes, of increasing density with infill buildings, rehabilitation of the large underutilized buildings. Improve the public spaces to be more pedestrian and bicycle friendly, with new green space areas interspersed throughout the downtown and develop a strong connection to the river with an arcade over the highway. Create more coherent parking sites instead of the patchwork of public and private parking lots and create new streets within the Metro Square and Inn at Middletown blocks.

Comparing the existing building square footage, commercial and residential, developing the charrette result would double the density of the downtown with increasing the current 2,916,253 sqft by 2,596,517 sqft. to a total of 5,512,770 sqft.

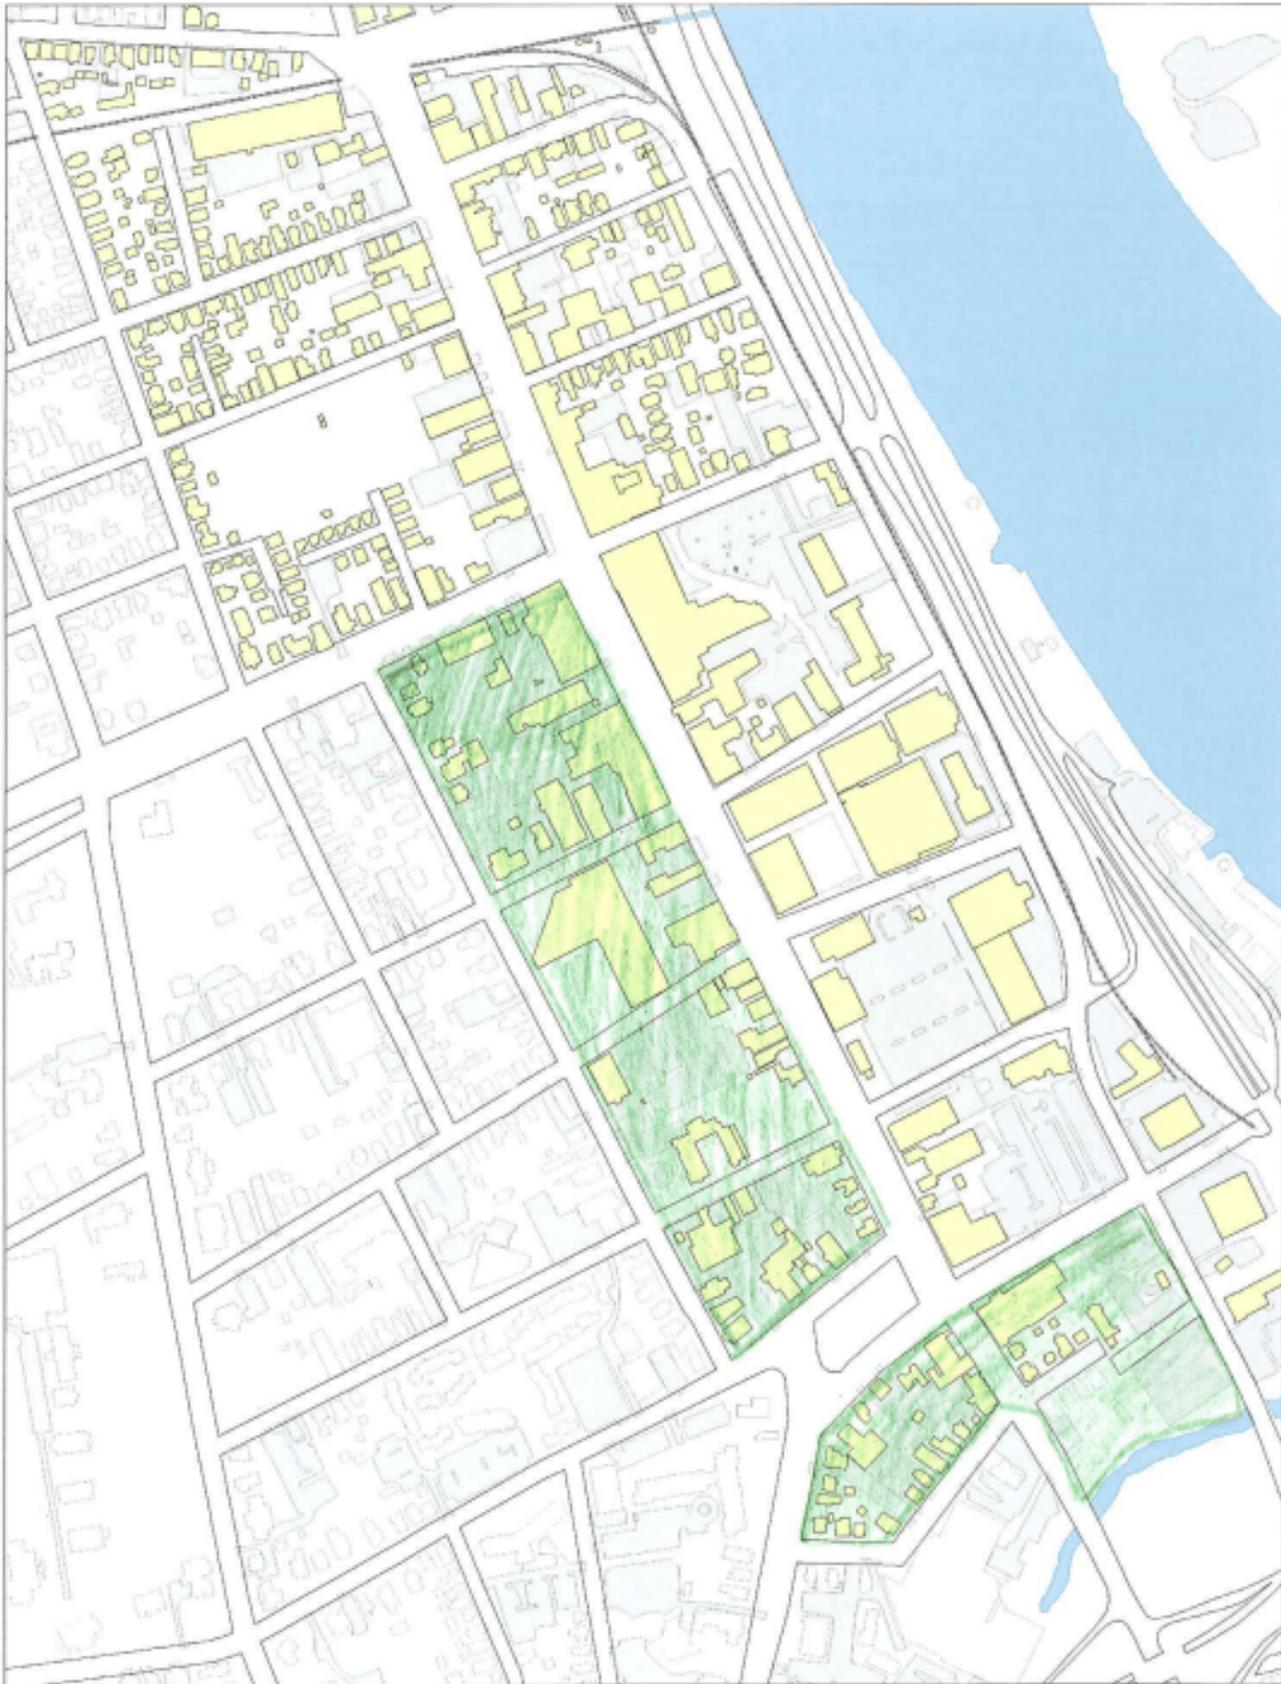
Map 4- Area Scores Map

GREEN- 6.0 or greater

RED- 4.0 or less

<u>Study Area</u>	<u>Score</u>	
East of Main St / North of Washington St		4.9
East of Main St / South of Washington St	5.1	
West of Main St / North of Washington St	5.6	
West of Main St / South of Washington St	6.5	
South of Union St and Pleasant St	6.8

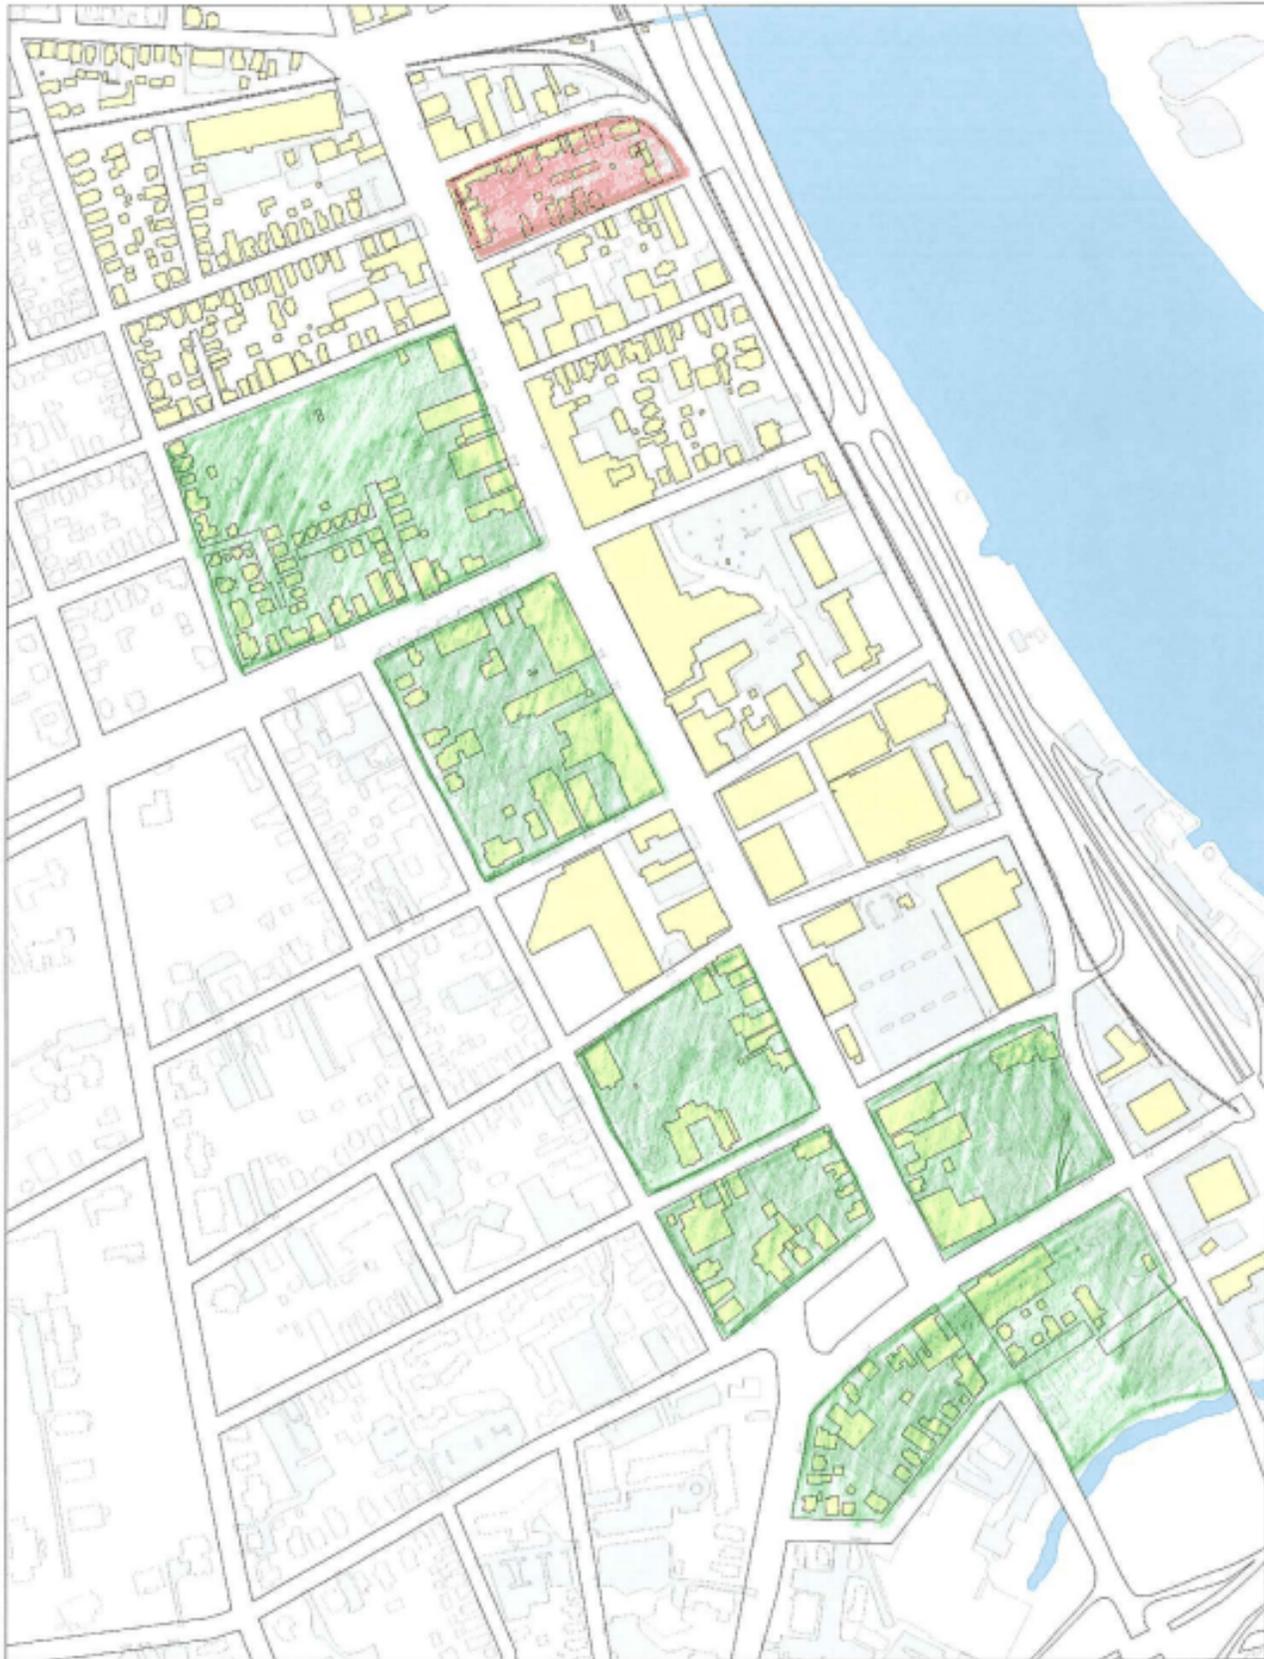
Map 5- Block Scores Map

GREEN- 6.0 or greater

RED- 4.0 or less

<u>Block</u>	<u>Score</u>	
North of Rapallo Ave Block	5.9	
Rapallo Ave / Main St / Green St / DeKoven Dr Block		3.8
Green St / Main St / Ferry St / DeKoven Dr Block	4.2	
Ferry St / Main St / Washington St / DeKoven Dr Block		5.5
Washington St / Main St/ Court St / DeKoven Dr Block		4.8
MLK Jr Way / Main St / Union St / DeKoven Dr Block		6.1
South Main St / Pleasant St / Main St Ext / Crescent St		6.8
Williams St/ Broad St / Old Church St / Main St		7.8
College St / Broad St / William St / Main St		7.0
Court St / Broad St / College St / Main St	5.3	
Washington St / Broad St / Court St / Main St		6.1
Liberty St / Pearl St / Washington St / Main St		6.3
Grand St / Pearl St / Liberty St / Main St		5.8
Spring St / Pearl St / Grand St / Main St		4.0

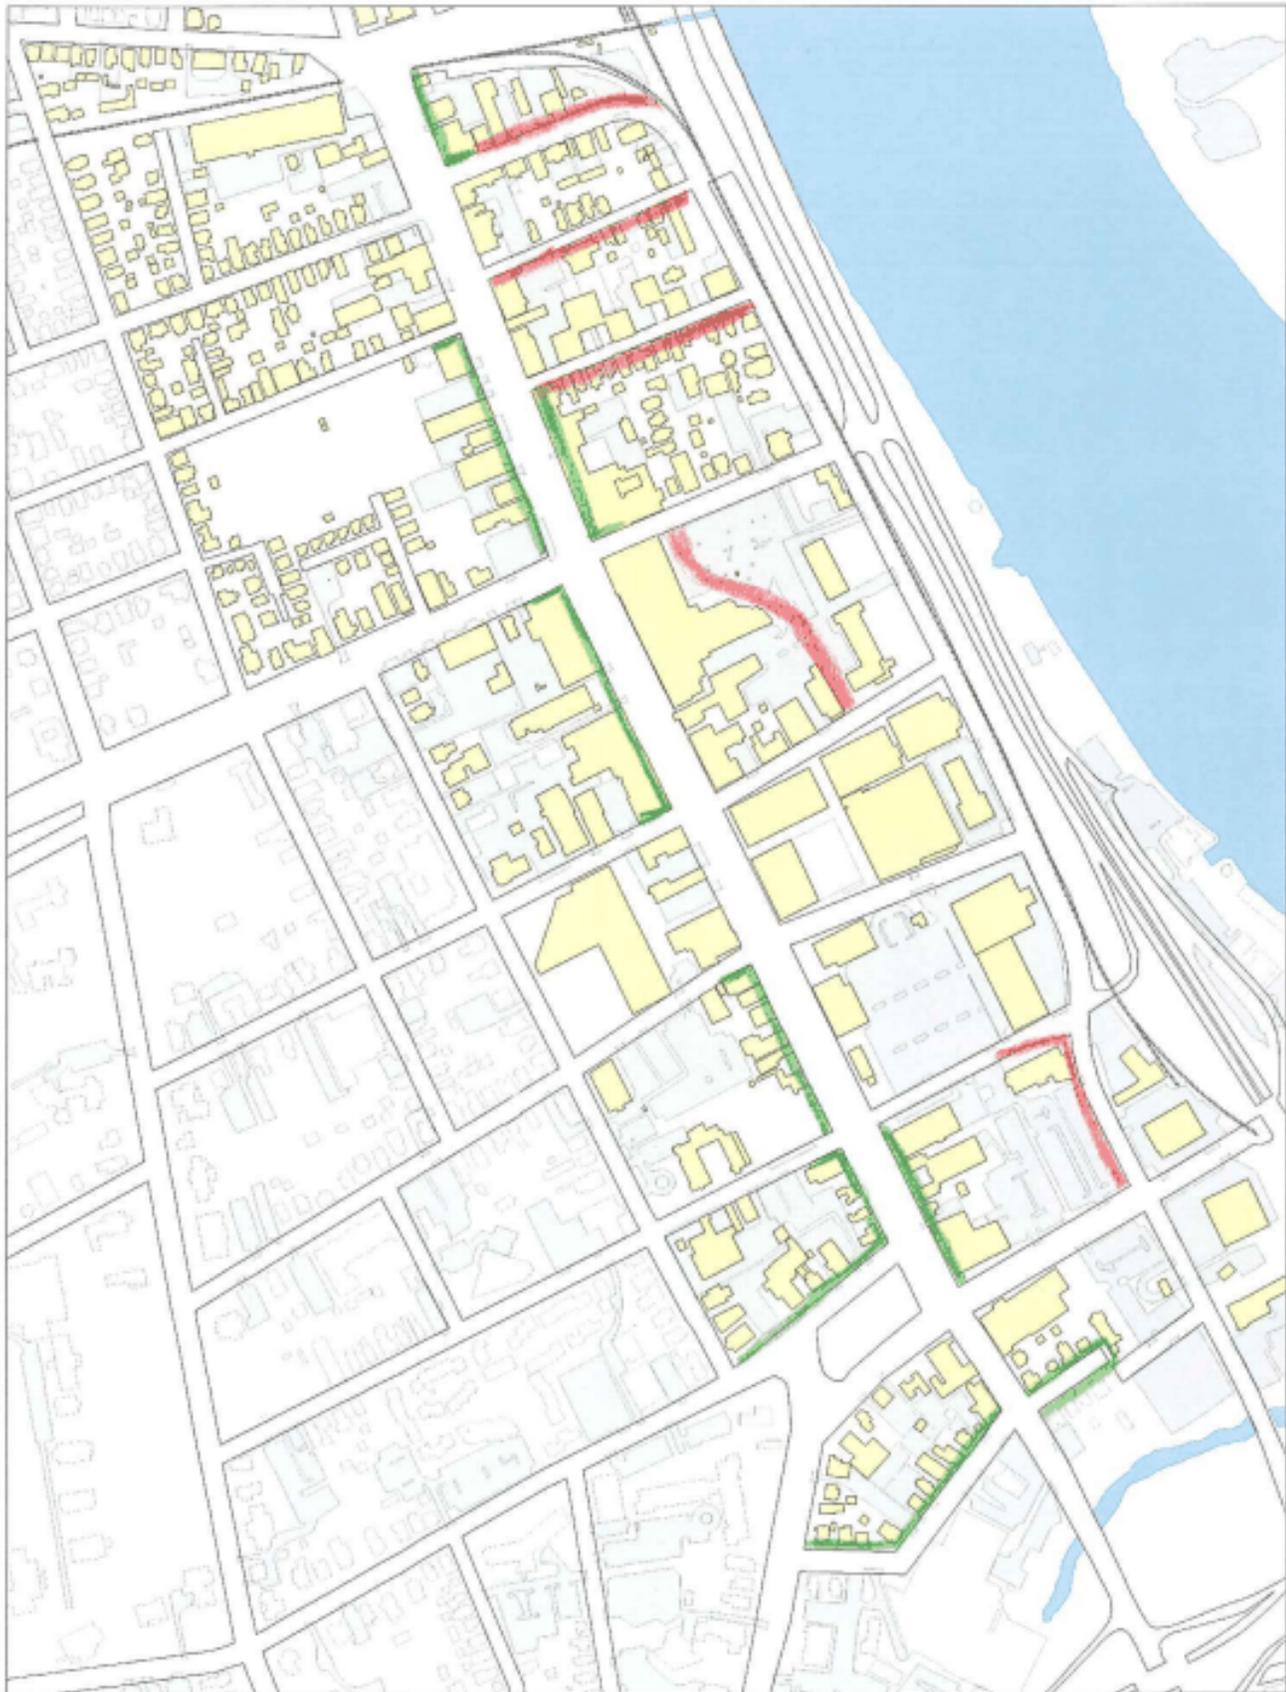
Map 6- Streetscape Scores Map

GREEN- 6.0 or greater

RED- 4.0 or less

<u>Streetscape</u>	<u>Score</u>	
Main St north of Rapallo Ave	6.2	
Rapallo Ave, North side		5.3
Green St North Side	3.1	
Main St, east side between Green Street and Rapallo Av		4.9
Green St, South Side	2.6	
Main St, east side between Green Street and Ferry St		5.0
Ferry St, north side	4.4	
Ferry St, south side	3.8	
Main St, east side between Ferry St and Washington St		6.7
Washington St, east of Main St, north side	5.3	
Alsop Ave	5.1	
Main St, east side between Washington St and Court St		5.4
Melilli Pl	2.8	
Court St, north side	4.3	
Main St, east side between MLK Jr Way and Union St		7.5
DeKoven Dr, west side between MLK Jr Way and Union St		3.4
Crescent St	7.6	
South Main St, east side between Crescent St and Pleasant St		5.4
MacDonough Pl		7.0
Main St, west side between William St and Old Church St		8.7
Old Church St	6.5	
Main St, west side between College St and William St		8.0
Broad St, east side between College St and Church St		4.5

Main St, west side between Court St and College St		5.1
Court St, north side between Main St and Broad St		5.0
Main St, west side between Washington St and Court St		6.3
Main St, west side between Liberty St and Washington St		6.3
Main St, west side between Grand St and Liberty St		5.8
Main St, west side between Spring St and Grand St		4.0
