AAI Phase I Environmental Site Assessment

61 Durant Terrace
Middletown, Connecticut

Prepared for City of Middletown
245 deKoven Drive
Middletown, Connecticut 06457

November 2010

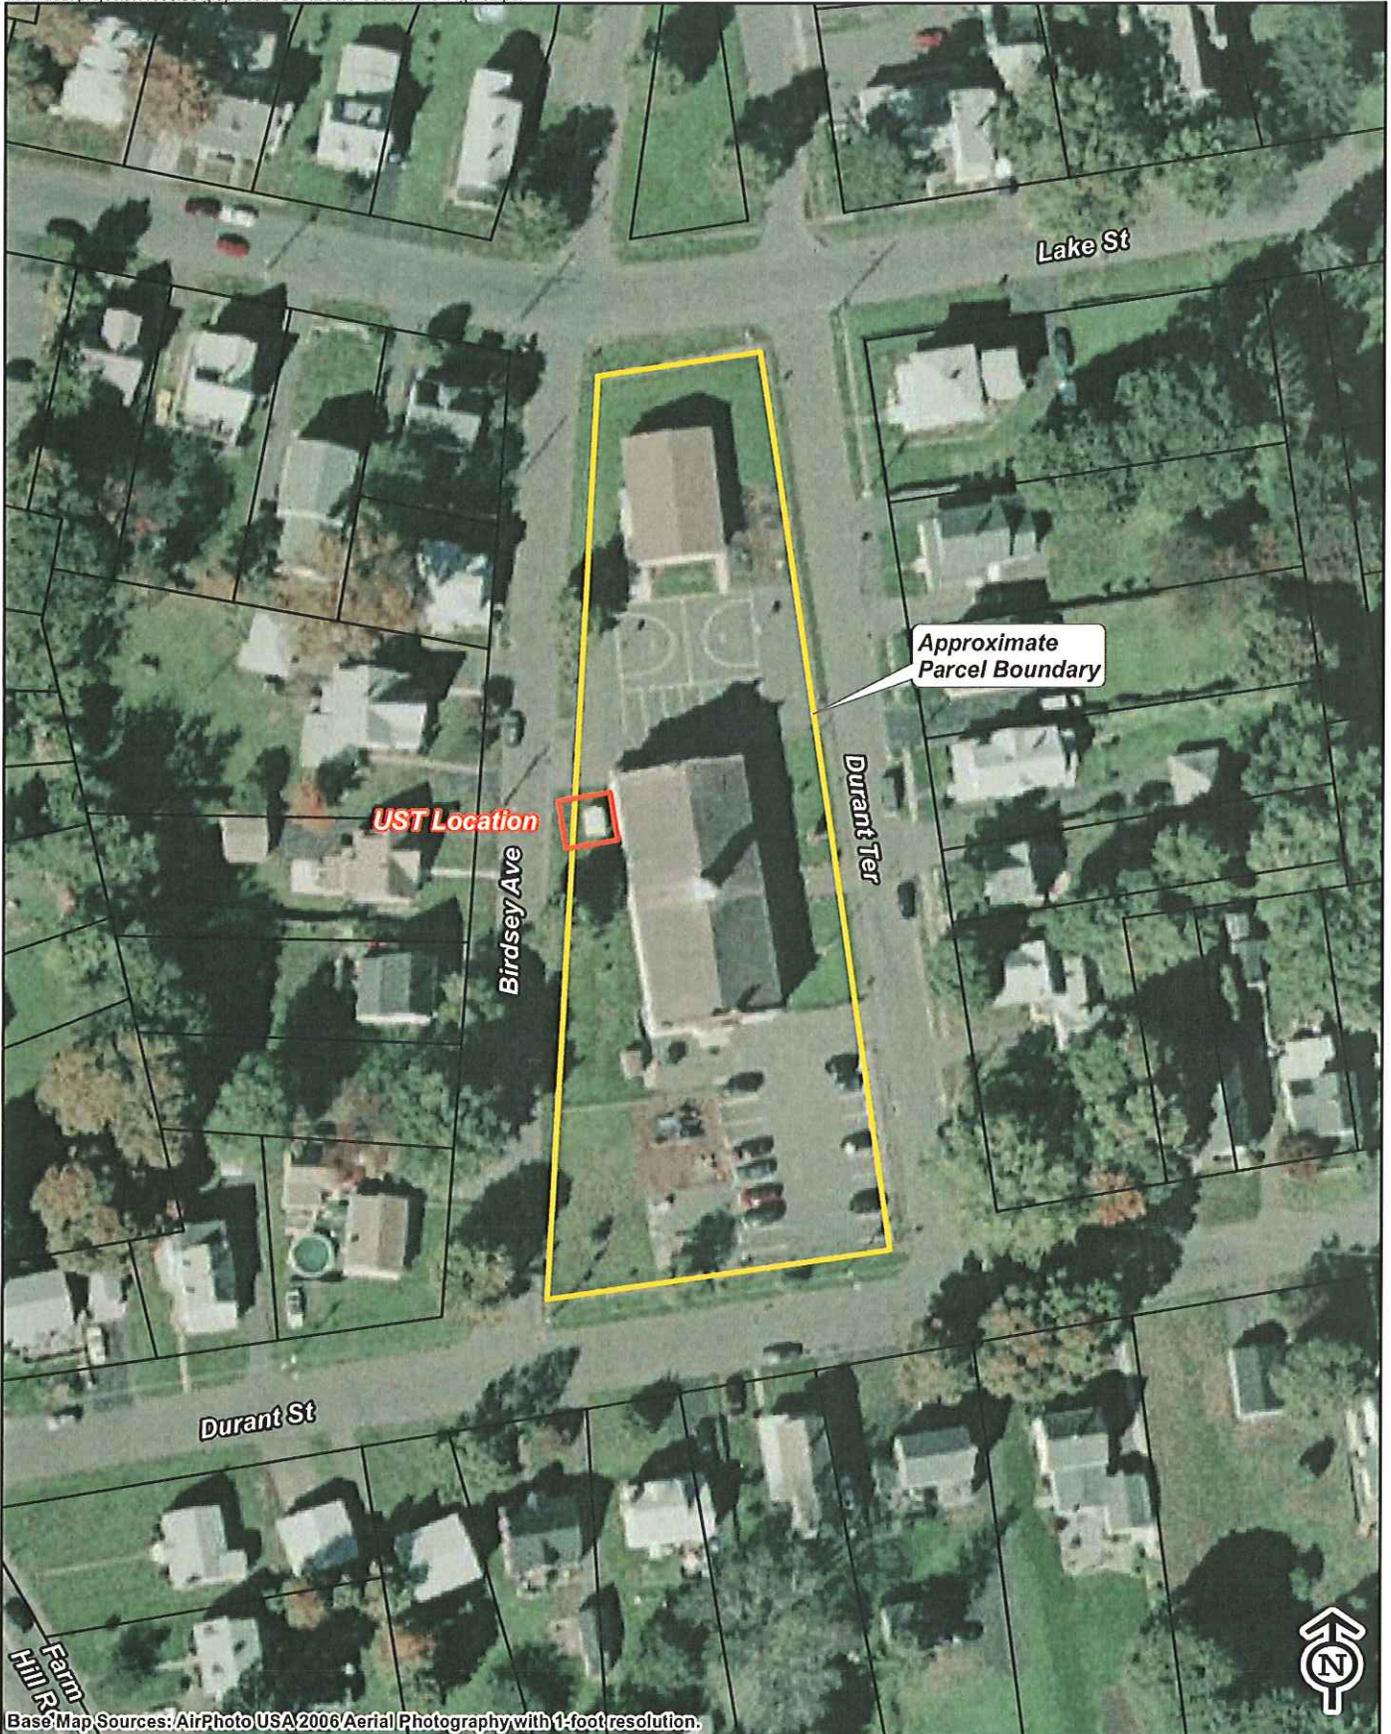
Base Map Sources: AirPhoto USA 2006 Aerial Photography with 1-foot resolution.

Figure No.	Title
1	Site Location Map
2	Site Plan
