HISTORIC RESOURCES INVENTORY FORM  
For Buildings and Structures

1. BUILDING NAME: Common: First Church of Christ Congregational Historic: same
2. TOWN/CITY: Middletown VILLAGE: \_\_\_\_\_ COUNTY: Middlesex
3. STREET & NUMBER (and/or location): 190 Court Street
4. OWNER(S): The First Ecclesiastical Society PUBLIC  PRIVATE
5. USE: Present: Church Historic: same
6. ACCESSIBILITY TO PUBLIC: Exterior visible from public road:  yes  no  
Interior accessible:  yes, explain religious use  no

Architect: C.C. Nicholas of Albany, New York Builder: \_\_\_\_\_  
18. HISTORICAL OR ARCHITECTURAL IMPORTANCE: This church, built in 1871-72, is the fifth meeting house of The First Ecclesiastical Society, the oldest religious organization in Middletown. Traditionally, this church's congregation has been composed of many prominent city residents. Since this building's erection, its membership has included Woodrow Wilson and state governors Frank B. Weeks and Owen V. Coffin. Notable church pastors were Azel W. Hazen (pastor 1868-1919), author of a history of the church and Douglas Horton, the succeeding pastor who later became Dean of the Harvard Divinity School.

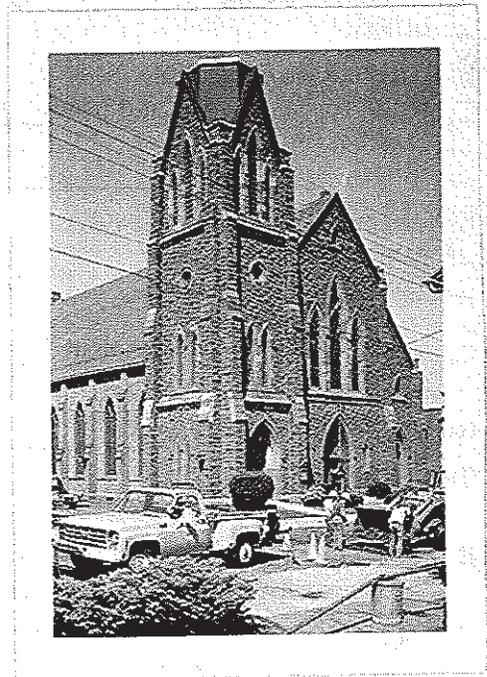
photographer: Robert Svec  
date: 9/78 view: south  
negative on file: Roll 31, #13

7. STYLE OF BUILDING: Gothic Revival DATE OF CONSTRUCTION: 1871-1872
8. MATERIAL(S) (indicate use or location when appropriate):  
 clapboard  asbestos siding  brick except facade  
 wood shingle  asphalt siding  fieldstone  
 board & batten  stucco  cobblestone  
 aluminum siding  concrete: type: \_\_\_\_\_  cut stone: type: brownstone  
 other: \_\_\_\_\_ facade  
(coursed ashlar)

13. INTEGRITY: Location:  on original site  moved, when: \_\_\_\_\_  
Alterations:  no  yes, explain: Rear wing added (1926); spire, pinnacles, dorm-  
ers removed

This Gothic Revival edifice was designed by C.C. Nicholas of Albany, New York. A six-bay buttressed brick main section encloses a modest interior with a plaster vaulted ceiling. The facade is of brownstone and derives a distinctly textural effect from the contrast of its rock faced ashlar walls with the smooth finished stone of its window and entrance moldings. The elements of the central facade are symmetrically arranged; over the large pointed arch portal are three pointed arch tracery windows. A square buttressed brownstone tower is incorporated into the southwest corner of the facade. The spire damaged in the

hurricane of 1938 and accompanying pinnacles have been removed, thus somewhat reducing the original vertical emphasis of the building.
