HISTORIC RESOURCES INVENTORY FORM

- 1. BUILDING NAME: Common: _____ Historic: George R. Finley House
- 2. TOWN/CITY: Middletown VILLAGE: _____ COUNTY: Middlesex
- 3. STREET & NUMBER (and/or location): 49 Crescent Street
- 4. OWNER(S): Middlesex Memorial Hospital PUBLIC PRIVATE
- 5. USE: Present: Vacant Historic: _____
- 6. ACCESSIBILITY TO PUBLIC: Exterior visible from public road: yes no
Interior accessible: yes, explain _____ no

- 7. STYLE OF BUILDING: Second Empire DATE OF CONSTRUCTION: 1872-73
- 8. MATERIAL(S) (indicate use or location when appropriate):

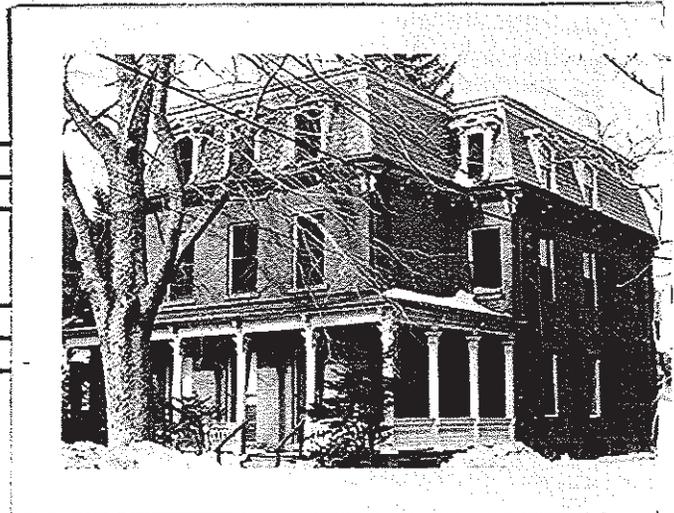
photographer: E. Loomis
date: 2/78 view: south
negative on file: Roll 15, #6A

The imposing quality of this house is derived from its large size and masonry construction. The exterior features are almost completely original, including the one story veranda, two-story bay window on the west side, and copper gutters and flashing. The house displays decorative features of the Second Empire style such as the scrolled brackets, mansard roof, and elaborately pedimented and bracketed dormer windows.
