HISTORIC RESOURCES INVENTORY FORM  
for Buildings and Structures

1. BUILDING NAME: Common: \_\_\_\_\_ Historic: Warner House

3. STREET & NUMBER (and/or location): 1 George Street

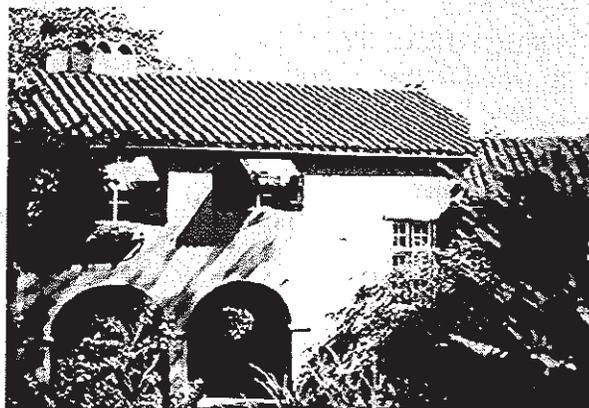
photographer: Roger Sherman  
date: 9/78 view: east  
negative on file: Roll 42, #14-14A

The main building has a 2½-story main block with matching wings that angle toward the roadway. The house is set below road level with terraced gardens and a fountain leading to the facade. A front porch in loggia-style is pierced with round-arched openings. Behind the house the land slopes down toward the Coginchaug River in the Middlefield Street-Boston Road area. A large garage to the north of the main building and a commodious guest house are finished in the same Spanish Colonial Revival style. Inside, the same high quality of period reproduction prevails. There are terra cotta floor tiles, stuccoed walls, exposed beams, and large hooded fireplaces. Just off the main entrance, a hand-carved
