HISTORIC RESOURCES INVENTORY FORM

1. BUILDING NAME: Common: Terry's Beauty Salon Historic: Arthur Magill Jr. House; Chase School
2. TOWN/CITY: Middletown VILLAGE: _____ COUNTY: Middlesex
3. STREET & NUMBER (and/or location): 631 Main Street
4. OWNER(S): Vincent and Joyce Conroy PUBLIC PRIVATE
5. USE: Present: Apartments & beauty salon Historic: Residence, school, hotel
6. ACCESSIBILITY TO PUBLIC: Exterior visible from public road: yes no
Interior accessible: yes, explain _____ no

Arthur Magill Jr. House; Chase School
631 Main Street, Middletown, Ct. 06457

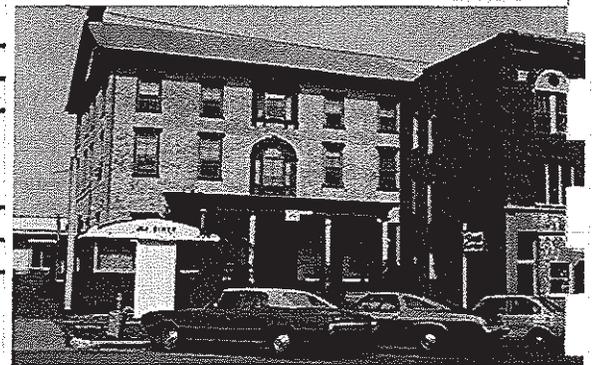
photographer: Elizabeth Loomis
date: 6/78 view: east
negative on file: Roll 27, #19A

7. STYLE OF BUILDING: Federal-Greek DATE OF CONSTRUCTION: c. 1820
8. MATERIAL(S) (indicate use or location when appropriate):
 ___clapboard ___asbestos siding brick
 ___wood shingle ___asphalt siding ___fieldstone
 ___board & batten ___stucco ___cobblestone
 ___aluminum siding ___concrete: type: _____ cut stone: type: brownstone
 ___other: _____ foundation & watertable; sills and lintels

11. NUMBER OF STORIES: 3½ APPROXIMATE DIMENSIONS: 50'x41'
12. CONDITION: Structural: ___ excellent ___good fair ___deteriorated
 Exterior: ___ excellent ___good fair ___deteriorated

13. INTEGRITY: Location: on original site West rear wing removed; later front veranda; fire
 Alterations: ___ no ___ yes, explain: staircase added in rear; door and large window
added to first floor facade

Brownstone Palladian window
Copper gutters

Its large size, brownstone trim, and decorative detail make this building one of the finest mansions built in the late Federal style in Middletown. Federal decorative elements (a Palladian window and a Federal doorway with fanlight and sidelights) are used
