HISTORIC RESOURCES INVENTORY FORM  
For Buildings and Structures

- 1. BUILDING NAME: Common: Highlawn Historic: same
- 2. TOWN/CITY: Middletown VILLAGE: Staddle Hill COUNTY: Middlesex
- 3. STREET & NUMBER (and/or location): Washington St. Ext.; north side, near Middlefield Town Line
- 4. OWNER(S): John R. Camp PUBLIC  PRIVATE
- 5. USE: Present: Residence Historic: same
- 6. ACCESSIBILITY TO PUBLIC: Exterior visible from public road:  yes  no  
Interior accessible:  yes, explain \_\_\_\_\_  no

- 7. STYLE OF BUILDING: Colonial Revival DATE OF CONSTRUCTION: 1916
- 8. MATERIAL(S) (indicate use or location when appropriate):

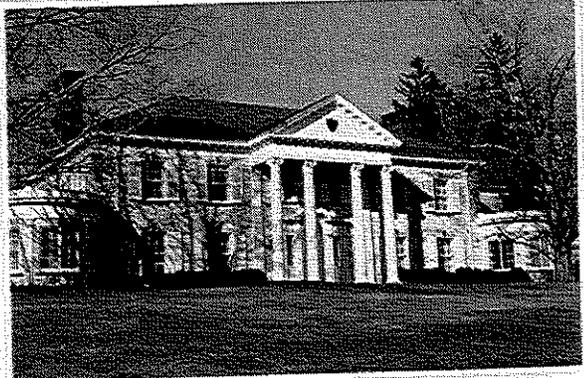
photographer: John E. Reynolds  
date: 1/79 view: east  
negative on file: Roll 58, #14

- Large Colonial Revival entrance doorway with broken pediment
- Porte Cochere over rear entrance
- Flared brownstone lintels
- Panelled exterior shutters

LeRoy P. Ward, a local architect, designed this building in the Colonial Revival style. The large central block of the main structure is flanked by wings with rounded bays at the front. The building's classical symmetry is only slightly marred by a small attached garage on the north side which is sympathetic to the original in design and materials. Lavish use of Georgian details such as the large entrance with broken scroll pediment accents the overall symmetry of the center-hall plan.
